# Exploitation and Wear Properties of Nanostructured WC-Co Tool Modified with Plasma-Assisted Chemical Vapor Deposition TiBN Coating

Source / Izvornik: **Metals**, 2021, 11, 1 - 19

**Keywords:** PACVD; TiBN; cemented carbides; sliding wear; turning

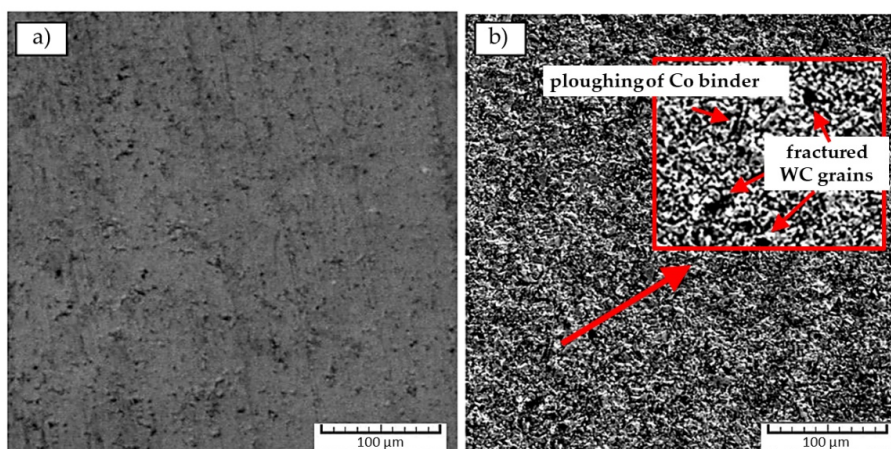
**Figure 7.** SEM micrographs of the SH-10 sample before; and (a) after erosion wear; (b) at an angle of 90°.

The results obtained from erosion testing with erodent impact angle of  $30^\circ$  indicate more pronounced wear occurring for cemented carbide samples with higher Co binder, expressed as higher loss of sample mass. For an impact angle of  $90^\circ$  higher loss of mass is detected for samples with lower Co content. Figure 7 shows the surface of the SH-10 sample before and after erosion wear at an erodent intrusion angle of  $90^\circ$ . Significant surface roughening caused by the impact of erosive particles is detected. Impact erosion governed by plowing of hard erodent through the softer binder phase along with fractures and pulling out of brittle WC phase is the main contributor for the mentioned surface roughening. It
