Source / Izvornik: **Metals, 2021, 11, 1 - 19**

Article

Exploitation and Wear Properties of Nanostructured WC-Co Tool Modified with Plasma-Assisted Chemical Vapor Deposition TiBN Coating

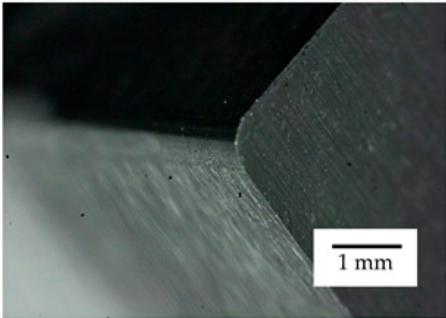
Table 11. Wear of sample SH-5 after turning test.

Table 11 presents the results for the sample of the SH-5 series. For this cemented carbide sample, the blade fracture occurred during tool/workpiece contact, which can be attributed to a large content of the fragile WC phase of high hardness that promoted brittle behavior, making this type of cemented carbide unsuitable for operation in real machining conditions.

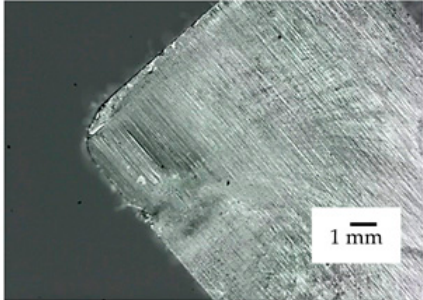
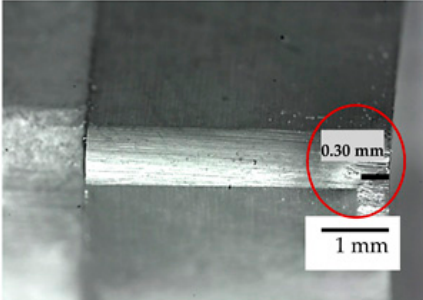
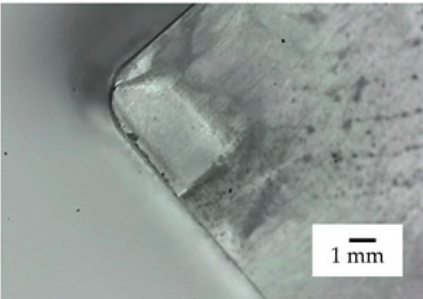
Table 12. Wear of sample SH-15 and reference K10 cutting insert after 15 min turning test.

Table 12 gives a comparison of the wear pattern of the SH-15 sample and the commercial K10 cutting insert under the same machining modes. By comparing the SH-15 and K10 inserts, a similar tribological behavior was observed during turning.

<p>A micrograph showing the rake face of the SH-15 cutting insert before turning. The surface is relatively smooth with fine, parallel machining marks. A 1 mm scale bar is located in the bottom right corner.</p>

<p>A micrograph showing the rake face of the SH-15 cutting insert after 15 minutes of single point turning. The surface shows significant wear, with a rougher texture and some material removal. A 1 mm scale bar is located in the bottom right corner.</p>
	Flank

<p>A micrograph showing the flank of the SH-15 cutting insert before turning. The surface is smooth and flat. A 1 mm scale bar is located in the bottom right corner.</p>

<p>A micrograph showing the flank of the SH-15 cutting insert after 15 minutes of single point turning. A red circle highlights a wear feature on the flank surface, with a measurement of 0.30 mm. A 1 mm scale bar is located in the bottom right corner.</p>

<p>A micrograph showing the rake face of the K-10 cutting insert before turning. The surface is smooth with fine, parallel machining marks. A 1 mm scale bar is located in the bottom right corner.</p>

<p>A micrograph showing the rake face of the K-10 cutting insert after 15 minutes of single point turning. The surface shows wear, with a rougher texture and some material removal. A 1 mm scale bar is located in the bottom right corner.</p>
	Flank

A small wear crater is visible on the rake face of the SH-15 cutting insert, while that on the commercial insert corresponds to the tool feed. The wear on the flank of the SH-15 insert was approximately 0.3 mm in length, which is the limit criterion of allowable wear. Commercially K10 insert did not meet the wear criteria after turning test due to trace size larger than 0.3 mm. Furthermore, a comparison of the inserts coated with TiBN coating was made, Table 13.

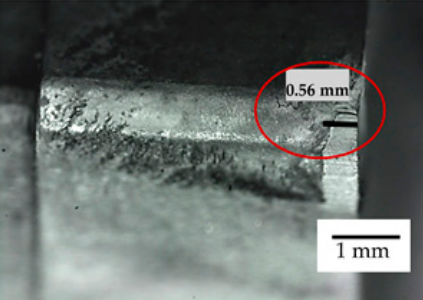
<p>A micrograph showing the flank of the K-10 cutting insert before turning. The surface is smooth and flat. A 1 mm scale bar is located in the bottom right corner.</p>

<p>A micrograph showing the flank of the K-10 cutting insert after 15 minutes of single point turning. A red circle highlights a wear feature on the flank surface, with a measurement of 0.56 mm. A 1 mm scale bar is located in the bottom right corner.</p>
