Exploitation and Wear Properties of Nanostructured WC-Co Tool Modified with Plasma-Assisted Chemical Vapor Deposition TiBN Coating

Abstract: In recent years, coated cemented carbides have often been the first choice for a wide variety of tool inserts and applications. Its success as a cutting tool material arises from the unique combination of wear resistance and toughness, and its ability to be formed into complex shapes. The structure obtained by sintering nanoparticle powders provides a significant improvement in product properties, such as higher cutting speeds, lower tool tolerances, and longer service life. In this study, a multi-layered gradient coating, deposited on nanostructured cemented carbides by plasma-assisted chemical vapor deposition (PACVD) was investigated with emphasis on its wear and exploitation properties. TiBN coating was deposited on nanostructured cemented carbide samples with the addition of 5 wt% Co, 10 wt% Co and 15 wt% Co. The samples were consolidated by one cycle hot isostatic pressing (HIP) technique. Complex architecture built of TiN and TiB₂ gradient multilayer sequence block was deposited on each type of substrate. Wear resistance of the obtaine

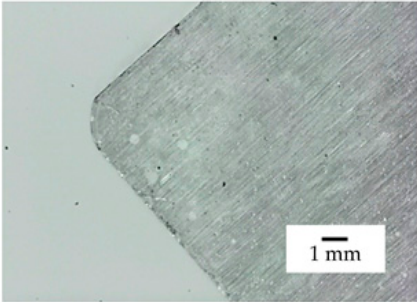
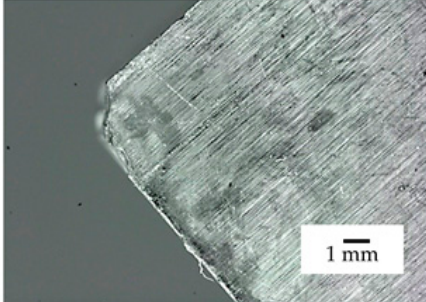
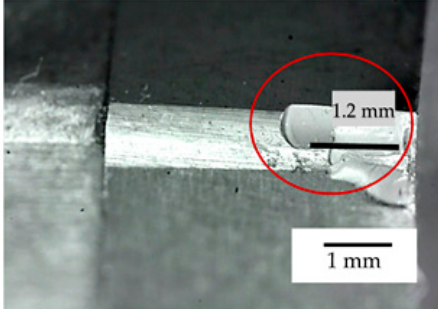
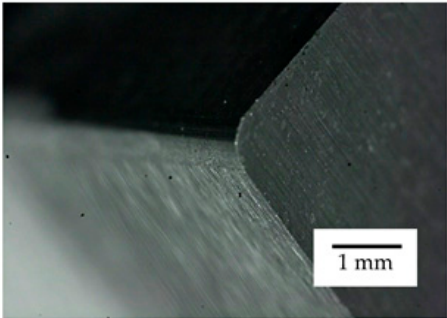
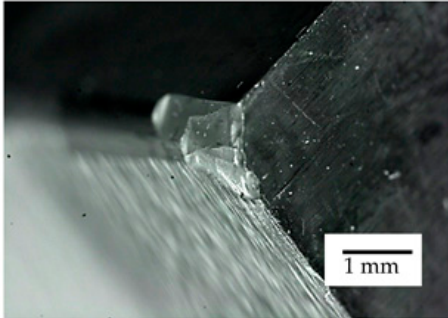
Table 11. Wear of sample SH-5 after turning test.

<p>Micrograph showing the rake face of the insert before turning. The surface is relatively smooth with fine, parallel striations. A 1 mm scale bar is present in the bottom right corner.</p>

<p>Micrograph showing the rake face of the insert after single-point turning. The surface shows significant wear and a rougher texture compared to the pre-turning state. A 1 mm scale bar is present in the bottom right corner.</p>
	Flank

<p>Micrograph showing the flank of the insert before turning. The surface is smooth and uniform. A 1 mm scale bar is present in the bottom right corner.</p>

<p>Micrograph showing the flank of the insert after single-point turning. A significant fracture is visible on the flank surface, circled in red. A 1.2 mm scale bar is present in the bottom right corner.</p>

<p>Micrograph showing the insert surface at a 45-degree angle before turning. The surface is smooth. A 1 mm scale bar is present in the bottom right corner.</p>

<p>Micrograph showing the insert surface at a 45-degree angle after single-point turning. The surface shows wear and a rougher texture. A 1 mm scale bar is present in the bottom right corner.</p>

Table 11 presents the results for the sample of the SH-5 series. For this cemented carbide sample, the blade fracture occurred during tool/workpiece contact, which can be attributed to a large content of the fragile WC phase of high hardness that promoted brittle behavior, making this type of cemented carbide unsuitable for operation in real machining conditions.

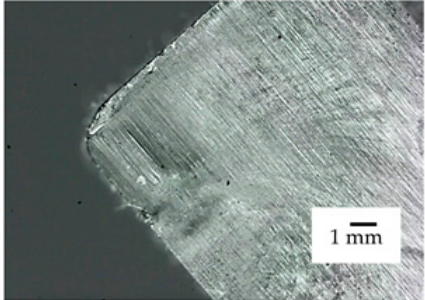
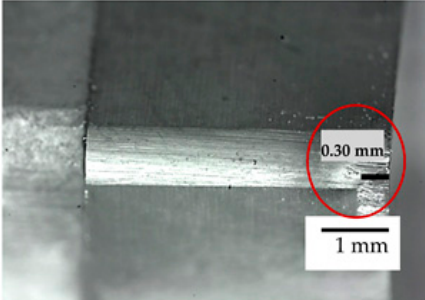
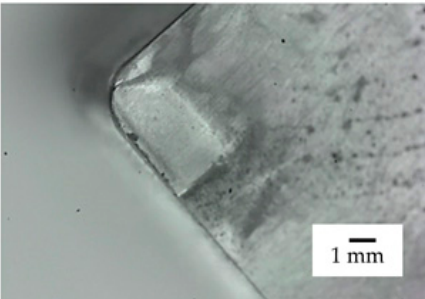
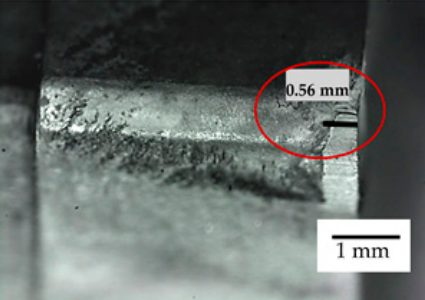
Table 12. Wear of sample SH-15 and reference K10 cutting insert after 15 min turning test.

<p>A micrograph showing the rake face of the SH-15 insert before turning. The surface is smooth with fine, parallel machining marks. A 1 mm scale bar is located in the bottom right corner.</p>

<p>A micrograph showing the rake face of the SH-15 insert after 15 minutes of single point turning. The surface shows significant wear and a rougher texture compared to the initial state. A 1 mm scale bar is located in the bottom right corner.</p>
	Flank

<p>A micrograph showing the flank of the SH-15 insert before turning. The surface is smooth and flat. A 1 mm scale bar is located in the bottom right corner.</p>

<p>A micrograph showing the flank of the SH-15 insert after 15 minutes of single point turning. A red circle highlights a wear feature on the flank with a measurement of 0.30 mm. A 1 mm scale bar is located in the bottom right corner.</p>

<p>A micrograph showing the rake face of the K-10 insert before turning. The surface is smooth with fine, parallel machining marks. A 1 mm scale bar is located in the bottom right corner.</p>

<p>A micrograph showing the rake face of the K-10 insert after 15 minutes of single point turning. The surface shows wear and a rougher texture. A 1 mm scale bar is located in the bottom right corner.</p>
	Flank

<p>A micrograph showing the flank of the K-10 insert before turning. The surface is smooth and flat. A 1 mm scale bar is located in the bottom right corner.</p>

<p>A micrograph showing the flank of the K-10 insert after 15 minutes of single point turning. A red circle highlights a wear feature on the flank with a measurement of 0.56 mm. A 1 mm scale bar is located in the bottom right corner.</p>

Table 12 gives a comparison of the wear pattern of the SH-15 sample and the commercial K10 cutting insert under the same machining modes. By comparing the SH-15 and K10 inserts, a similar tribological behavior was observed during turning.

A small wear crater is visible on the rake face of the SH-15 cutting insert, while that on the commercial insert corresponds to the tool feed. The wear on the flank of the SH-15 insert was approximately 0.3 mm in length, which is the limit criterion of allowable wear. Commercially K10 insert did not meet the wear criteria after turning test due to trace size larger than 0.3 mm. Furthermore, a comparison of the inserts coated with TiBN coating was made, Table 13.

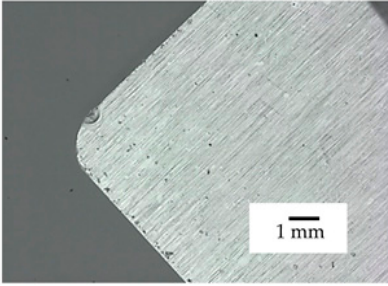
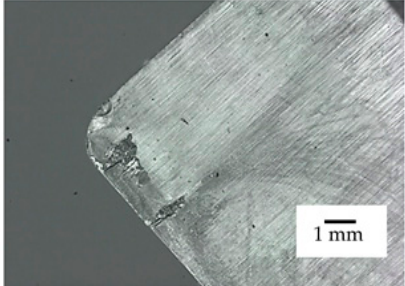
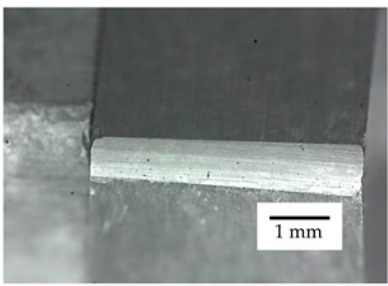
Table 13. Wear of samples SH-10-B and SH-15-B after 15 min turning test.

Samples SH-10-B and SH-15-B show an improvement in exploitation behavior. The cutting insert of the sample SH-10-B shows a wear trace of 0.25 mm, and for the sample

SH-15-B, it is approximately 0.21 mm. Both coated cemented carbide samples withstood 15 min of processing with wear trace size at the flank less than 0.3 mm. This presents the additional confirmation that cemented carbide cutting tools should be coated with TiBN coating since they show better wear resistance than uncoated tools and even commercially available cutting inserts.
