# Exploitation and Wear Properties of Nanostructured WC-Co Tool Modified with Plasma-Assisted Chemical Vapor Deposition TiBN Coating

Source / Izvornik: **Metals, 2021, 11, 1 - 19**

**Keywords:** PACVD; TiBN; cemented carbides; sliding wear; turning

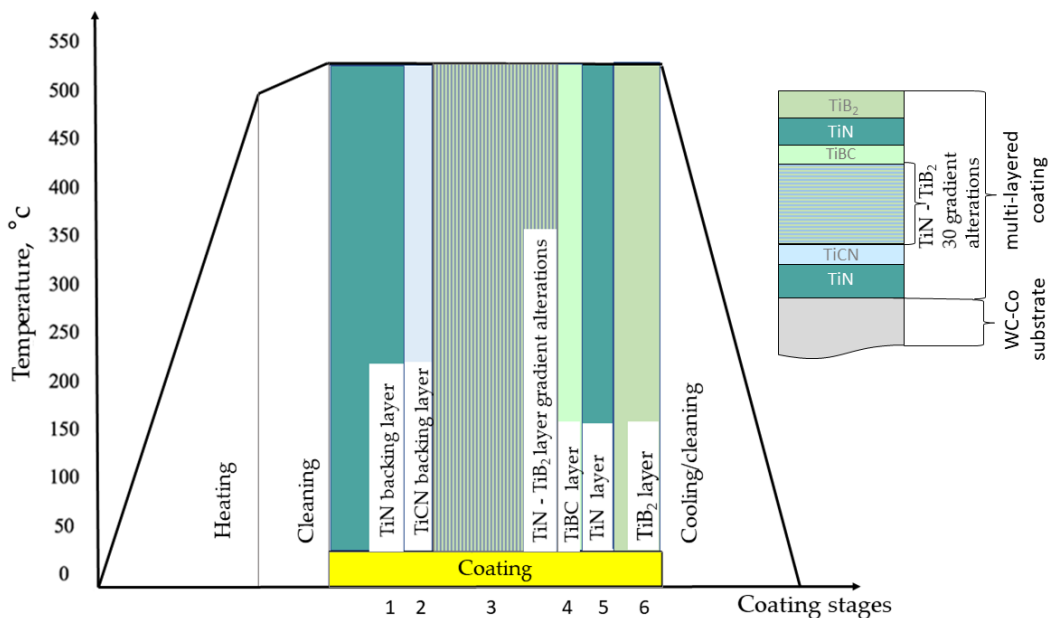
Figure 1. Coating process stages and architecture.

The coating on this surface was expected to exhibit better adhesion, thus better exploitation properties. Complex architecture built of TiN and TiB<sub>2</sub> layers, was deposited on four samples of each type of substrate with TiN as the backing layer, TiCN layer (using CH<sub>4</sub> precursor) followed by a block composed of thirty graded TiN/TiB<sub>2</sub> sequences, ending with a TiBC, TiN and TiB<sub>2</sub> layers on top. During TiN/TiB<sub>2</sub> sequence application, deposition time of the TiN layer was decreased with each step, while the application time of the TiB<sub>2</sub> layer was increased. The flow of N<sub>2</sub> was gradually reduced and at the same time the flow of BCl<sub>3</sub>, the precursor in charge of releasing boron, was increased accordingly. A gradual transition of layers was achieved so that a gradient multilayer coating deposition is ensured. TiCl<sub>4</sub> was used as a titanium precursor. Parameters used to achieve described multilayer system with gradient transition between altering layers are given in Table 3 and steps of the PACVD process including structure of obtained coating are shown in Figure 1. The properties of obtained samples are presented in Table 4.

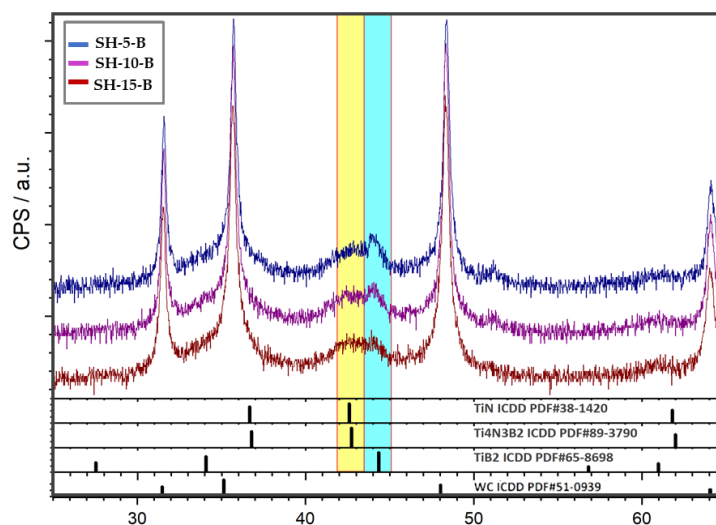
**Figure 2.** XRD patterns of coated samples: SH-5-B, SH-10-B and SH-15-B [35].

The x-ray diffraction (XRD) analysis of all three types of coated samples was conducted using the XRD6000 diffractometer (Shimadzu Corporation, Tokyo, Japan) with  $\text{CuK}\alpha$  radiation. Acceleration voltage of 40 kV and 30 mA current, in the  $2\theta$  range of  $2$  to  $120^\circ$  with a step of  $0.02^\circ$  and acquisition time of 0.6 s was applied. The obtained results indicated the hexagonal P-6m2 tungsten carbide (WC, ICDD PDF#51-0939) as major phase, Figure 2. Weak peak at  $44^\circ 2\theta$  suggest presence of hexagonal P6/mmm titanium boride ( $\text{TiB}_2$ , ICDD PDF#65-8698) in trace amounts. Cubic Fm- $m\bar{3}$  titanium nitride ( $\text{TiN}$ , ICDD PDF#38-1420) weak and broader peak was obtained at  $42^\circ 2\theta$ . This broader peak could indicate an additional phase present or titanium boronitride ( $\text{Ti}_4\text{N}_3\text{B}_2$ , ICDD PDF#89-3790) overlapping with titanium nitride. Establishing a definite distinction of the titanium nitride and titanium boronitride phases was difficult since they have very similar diffraction patterns arising from them being isostructural phases [35].

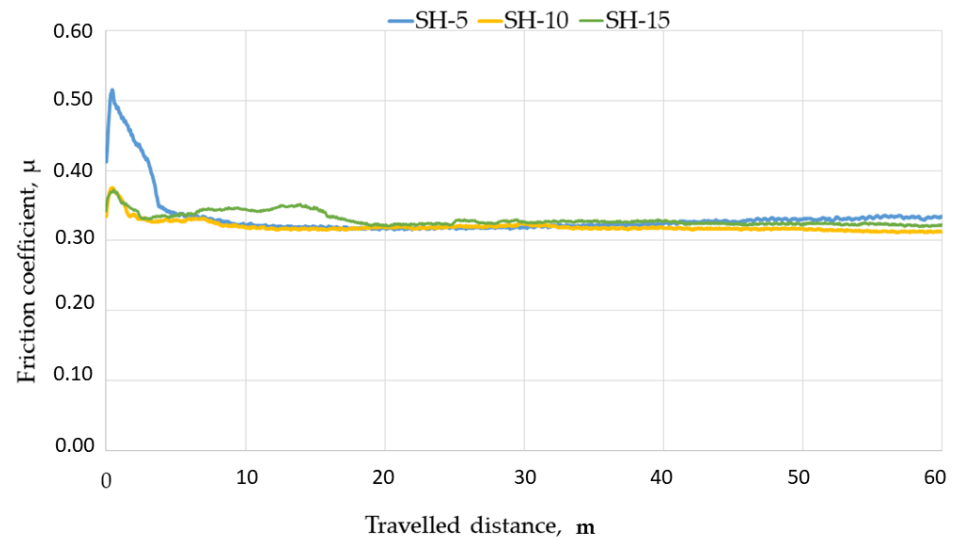
Figure 9. Mean values of friction coefficients for uncoated samples.

Figures 9 and 10 show the mean values of the friction factors for the tested substrate/coating systems. Three tests were performed on each sample.

A comparison of the obtained curves shows a higher friction factor for uncoated samples. It is obvious that the considered TiBN coating on cemented carbide samples greatly reduces friction, thus, increasing the resistance to dry sliding wear. The stronger variations of friction factors in TiBN coating at distances between 50 and 60 m, as shown in Figure 10, can be attributed to the coating entering and passing through different layers. The differences of the friction coefficient variations in a long running-in period involving 2/3 of the traveled distance should not be attributed to the coating architecture since it is the same in all tested samples. In that running-in period, the values of friction coefficients fall significantly as a result of sample surface smoothing, which is characteristic of all curves obtained by the ball-on-flat testing. The friction coefficient decrease observed for all three sample types during first 2/3 of test duration can be attributed to different initial roughness parameters of coated samples. The sharpest decrease in the friction coefficient can be observed for the SH-5-B, sample of the highest initial roughness. The smallest reduction of the friction coefficient was detected for the sample with the lowest roughness, the SH-15-B sample. Although, friction coefficient variations after 50 m of traveled distance

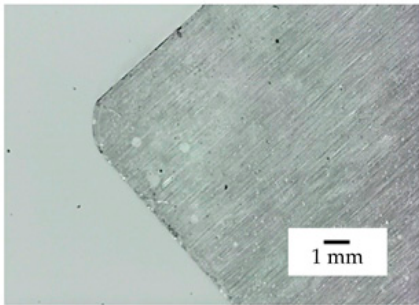
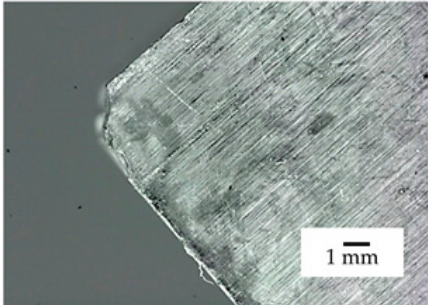
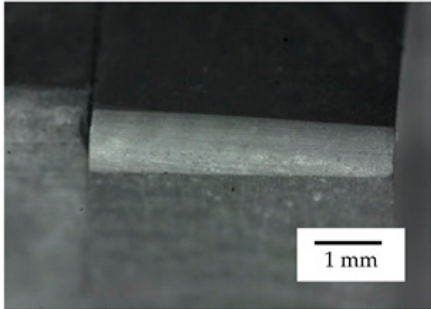
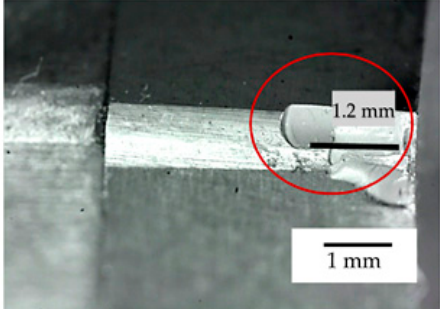
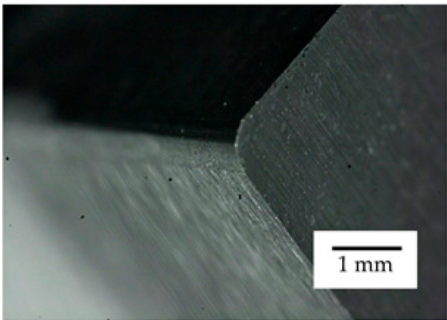
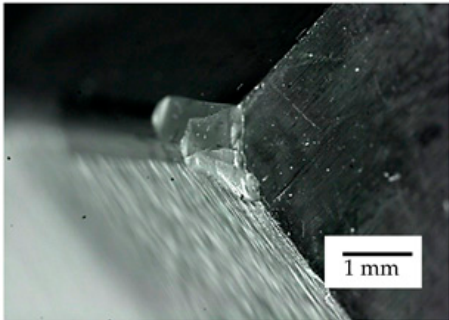
Table 11. Wear of sample SH-5 after turning test.

Table 11 presents the results for the sample of the SH-5 series. For this cemented carbide sample, the blade fracture occurred during tool/workpiece contact, which can be attributed to a large content of the fragile WC phase of high hardness that promoted brittle behavior, making this type of cemented carbide unsuitable for operation in real machining conditions.

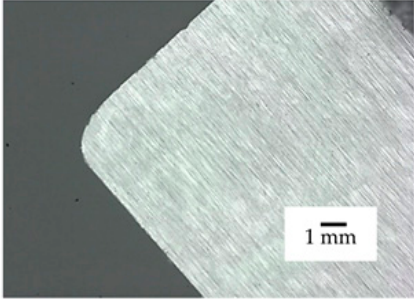
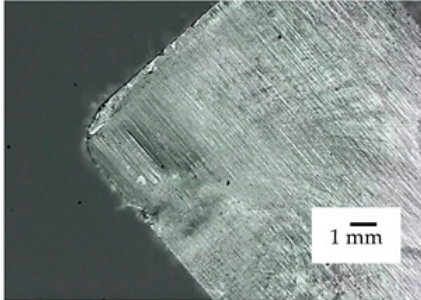
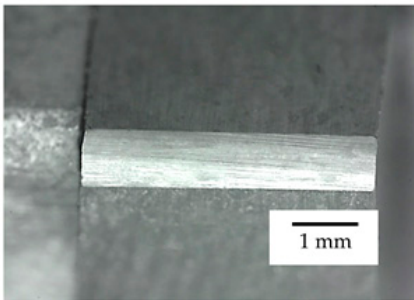
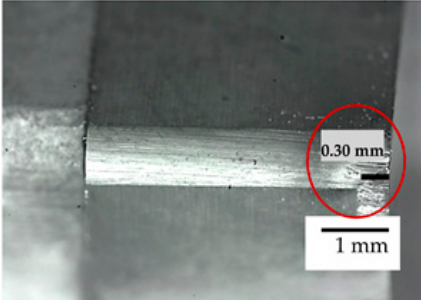
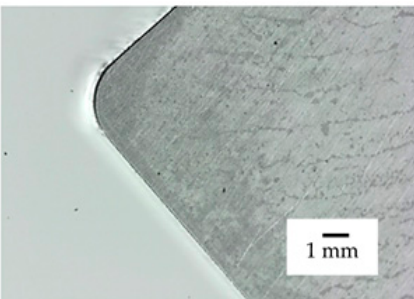
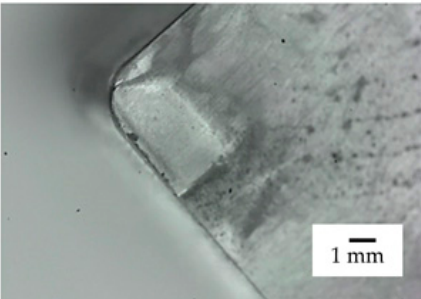
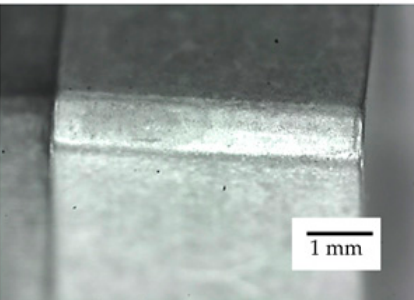
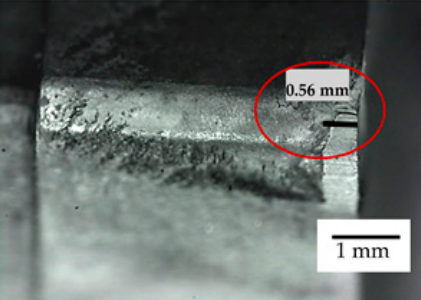
**Table 12.** Wear of sample SH-15 and reference K10 cutting insert after 15 min turning test.

Table 12 gives a comparison of the wear pattern of the SH-15 sample and the commercial K10 cutting insert under the same machining modes. By comparing the SH-15 and K10 inserts, a similar tribological behavior was observed during turning.

<p>A micrograph showing the rake face of the SH-15 cutting insert before turning. The surface is relatively smooth with fine, parallel machining marks. A 1 mm scale bar is located in the bottom right corner.</p>

<p>A micrograph showing the rake face of the SH-15 cutting insert after 15 minutes of single point turning. The surface shows significant wear, with a rougher texture and some material loss at the cutting edge. A 1 mm scale bar is located in the bottom right corner.</p>
	Flank

<p>A micrograph showing the flank of the SH-15 cutting insert before turning. The surface is smooth and flat. A 1 mm scale bar is located in the bottom right corner.</p>

<p>A micrograph showing the flank of the SH-15 cutting insert after 15 minutes of single point turning. A red circle highlights a wear feature on the flank with a measurement of 0.30 mm. A 1 mm scale bar is located in the bottom right corner.</p>

<p>A micrograph showing the rake face of the K-10 cutting insert before turning. The surface is smooth with fine, parallel machining marks. A 1 mm scale bar is located in the bottom right corner.</p>

<p>A micrograph showing the rake face of the K-10 cutting insert after 15 minutes of single point turning. The surface shows wear, with a rougher texture and some material loss at the cutting edge. A 1 mm scale bar is located in the bottom right corner.</p>
	Flank

<p>A micrograph showing the flank of the K-10 cutting insert before turning. The surface is smooth and flat. A 1 mm scale bar is located in the bottom right corner.</p>

<p>A micrograph showing the flank of the K-10 cutting insert after 15 minutes of single point turning. A red circle highlights a wear feature on the flank with a measurement of 0.56 mm. A 1 mm scale bar is located in the bottom right corner.</p>

A small wear crater is visible on the rake face of the SH-15 cutting insert, while that on the commercial insert corresponds to the tool feed. The wear on the flank of the SH-15 insert was approximately 0.3 mm in length, which is the limit criterion of allowable wear. Commercially K10 insert did not meet the wear criteria after turning test due to trace size larger than 0.3 mm. Furthermore, a comparison of the inserts coated with TiBN coating was made, Table 13.

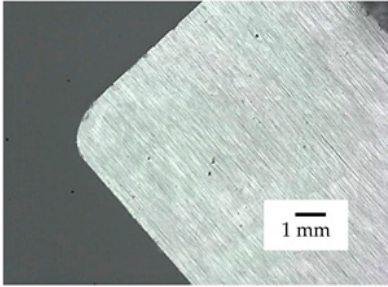
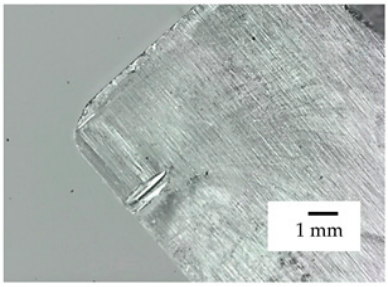
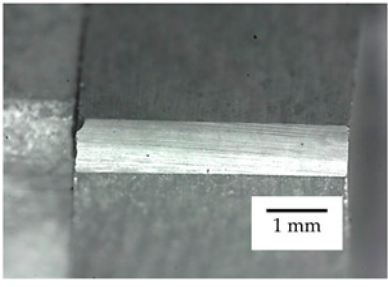
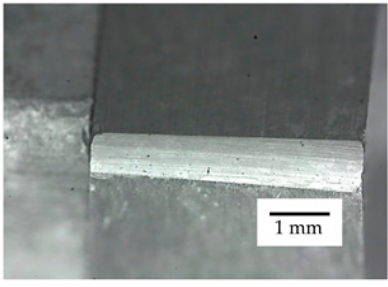
**Table 13.** Wear of samples SH-10-B and SH-15-B after 15 min turning test.

Samples SH-10-B and SH-15-B show an improvement in exploitation behavior. The cutting insert of the sample SH-10-B shows a wear trace of 0.25 mm, and for the sample

SH-15-B, it is approximately 0.21 mm. Both coated cemented carbide samples withstood 15 min of processing with wear trace size at the flank less than 0.3 mm. This presents the additional confirmation that cemented carbide cutting tools should be coated with TiBN coating since they show better wear resistance than uncoated tools and even commercially available cutting inserts.
