Exploitation and Wear Properties of Nanostructured WC-Co Tool Modified with Plasma-Assisted Chemical Vapor Deposition TiBN Coating

Abstract: In recent years, coated cemented carbides have often been the first choice for a wide variety of tool inserts and applications. Its success as a cutting tool material arises from the unique combination of wear resistance and toughness, and its ability to be formed into complex shapes. The structure obtained by sintering nanoparticle powders provides a significant improvement in product properties, such as higher cutting speeds, lower tool tolerances, and longer service life. In this study, a multi-layered gradient coating, deposited on nanostructured cemented carbides by plasma-assisted chemical vapor deposition (PACVD) was investigated with emphasis on its wear and exploitation properties. TiBN coating was deposited on nanostructured cemented carbide samples with the addition of 5 wt% Co, 10 wt% Co and 15 wt% Co. The samples were consolidated by one cycle hot isostatic pressing (HIP) technique. Complex architecture built of TiN and TiB₂ gradient multilayer sequence block was deposited on each type of substrate. Wear resistance of the obtaine

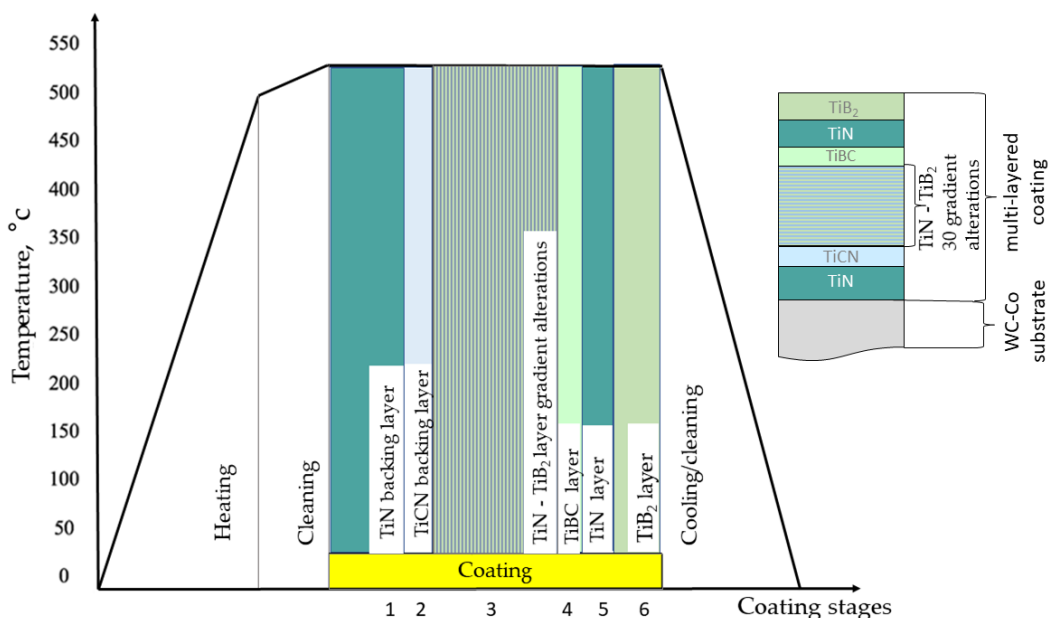
Figure 1. Coating process stages and architecture.

The coating on this surface was expected to exhibit better adhesion, thus better exploitation properties. Complex architecture built of TiN and TiB₂ layers, was deposited on four samples of each type of substrate with TiN as the backing layer, TiCN layer (using CH₄ precursor) followed by a block composed of thirty graded TiN/TiB₂ sequences, ending with a TiBC, TiN and TiB₂ layers on top. During TiN/TiB₂ sequence application, deposition time of the TiN layer was decreased with each step, while the application time of the TiB₂ layer was increased. The flow of N₂ was gradually reduced and at the same time the flow of BCl₃, the precursor in charge of releasing boron, was increased accordingly. A gradual transition of layers was achieved so that a gradient multilayer coating deposition is ensured. TiCl₄ was used as a titanium precursor. Parameters used to achieve described multilayer system with gradient transition between altering layers are given in Table 3 and steps of the PACVD process including structure of obtained coating are shown in Figure 1. The properties of obtained samples are presented in Table 4.
