Ocjena zaštitnih svojstava organiskih prevlaka na različitim metalnim podlogama

Master's thesis / Diplomski rad

UNIVERSITY OF ZAGREB
FACULTY OF MECHANICAL ENGINEERING AND
NAVAL ARCHITECTURE

Naslov rada na engleskom jeziku: **Evaluation of corrosion protection properties of organic coatings on different metal substrates**

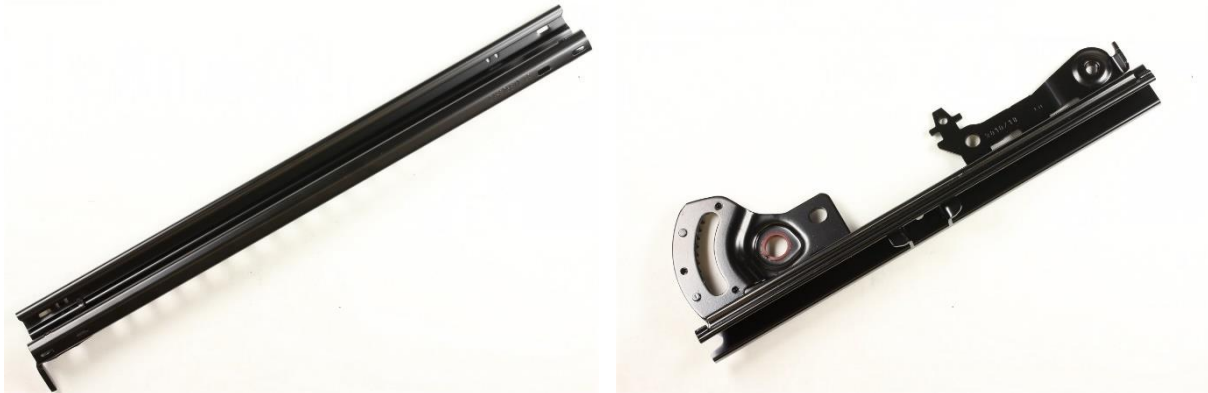
Steel on its own, even being utilized in the relatively inert cars interior, does not showcase sufficient corrosion resistance nor aesthetic properties. Therefore, the seat adjusters are coated by the process of cathodic electrodeposition.

Figure 2. Cathodic electrodeposition coated seat adjusters

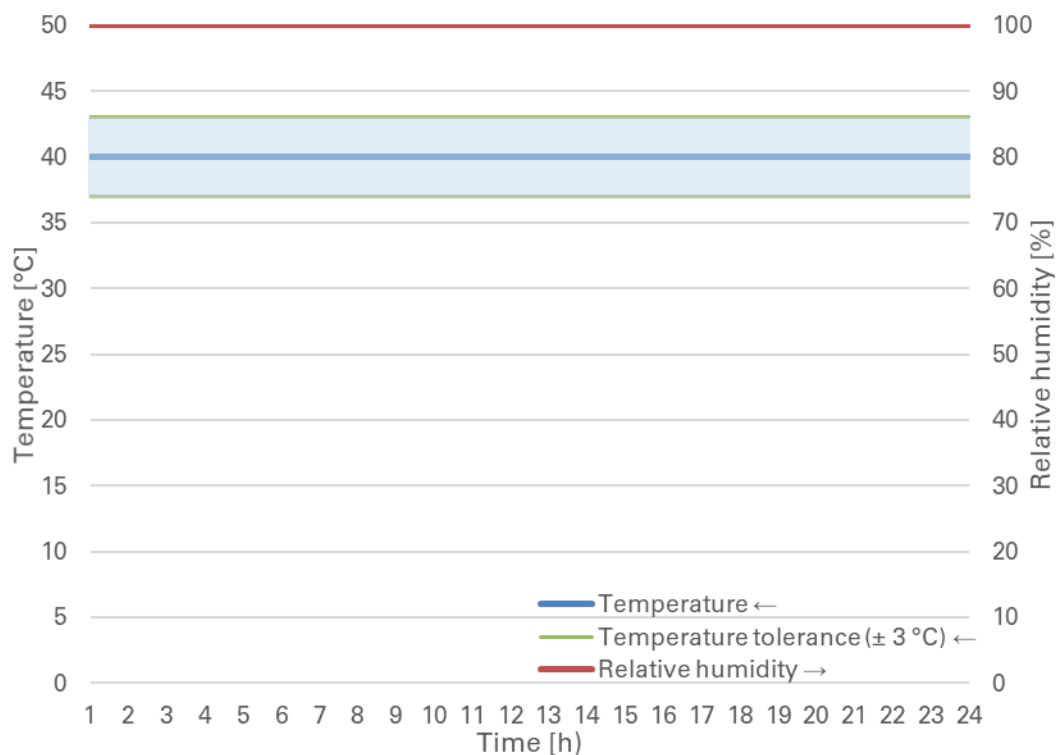
Figure 34. CH test operating parameters

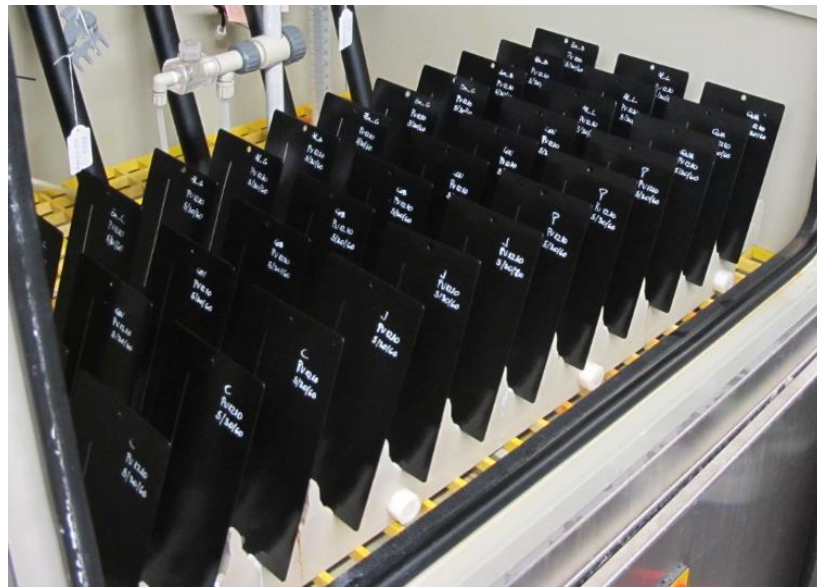
Figure 41. Placement of the specimens in the PV 12010 test chamber

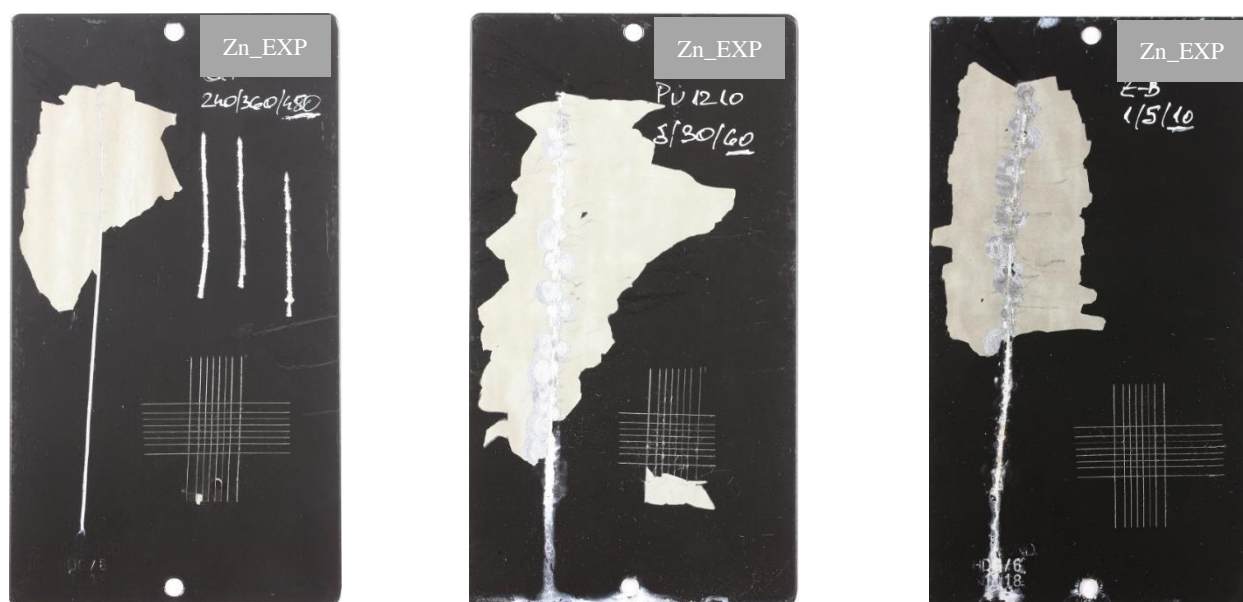
Figure 59. Zn_EXP specimens with poor coating adhesion after 480 hours of CH, 60 cycles of PV 1210, and 10 cycles of Cycle –B test
