# Ocjena zaštitnih svojstava organiskih prevlaka na različitim metalnim podlogama

**Master's thesis / Diplomski rad**

Naslov rada na engleskom jeziku: **Evaluation of corrosion protection properties of organic coatings on different metal substrates**

The aim of this masters thesis “Evaluation of corrosion protection properties of organic coatings on different metal substrates” is to examine the corrosion resistance properties of various CED and powder coatings, commonly utilized in the automotive industry. For this purpose, standardized steel, hot-dip galvanized steel and aluminium specimens are coated and subsequently tested in accelerated corrosion tests, the emphasis being on the climatic test according to VDA 233-102. The protective properties of the coatings are additionally studied using DC and AC electrochemical methods.

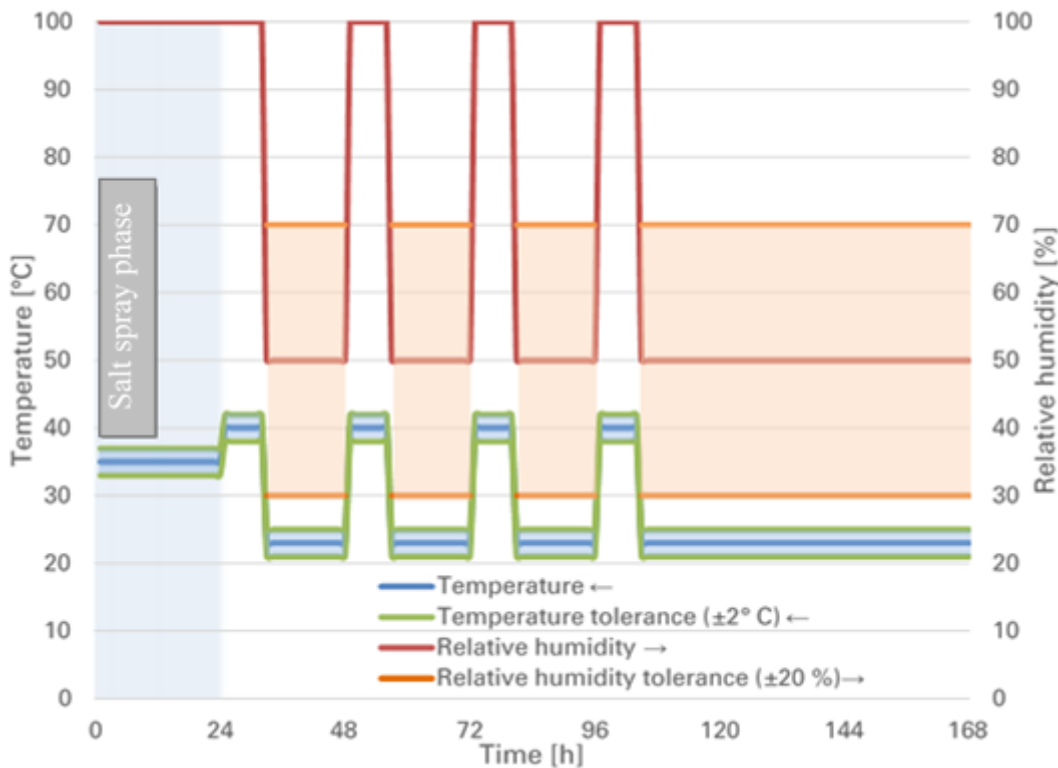
Figure 38. Cycle-B test operating parameters

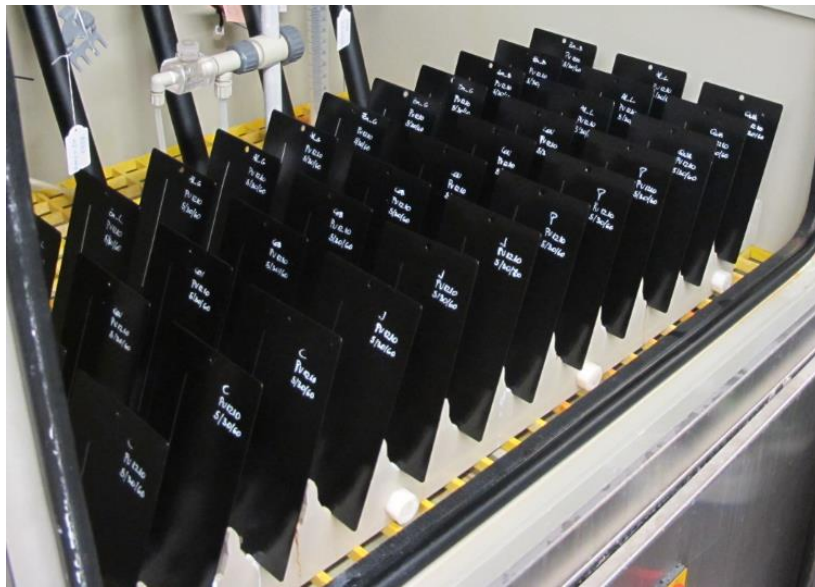
Figure 41. Placement of the specimens in the PV 12010 test chamber

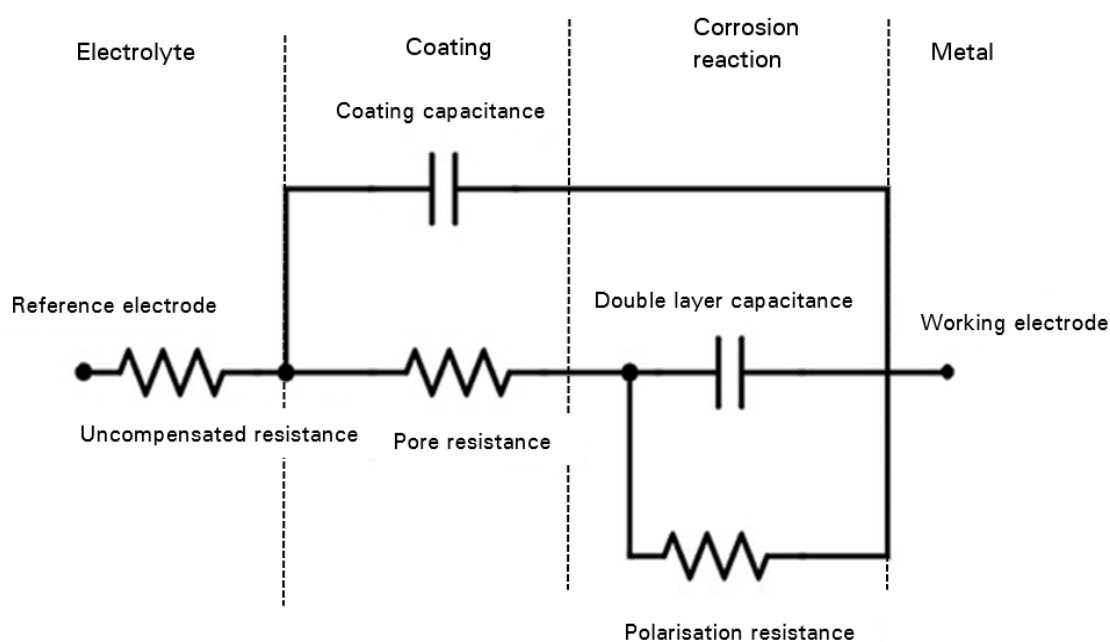
Figure 55. Sample electrical circle representing an organic coating in EIS results evaluation [39]
