# Ocjena zaštitnih svojstava organiskih prevlaka na različitim metalnim podlogama

# **MASTERS THESIS**

**Josip Novak**

Naslov rada na engleskom jeziku: **Evaluation of corrosion protection properties of organic coatings on different metal substrates**

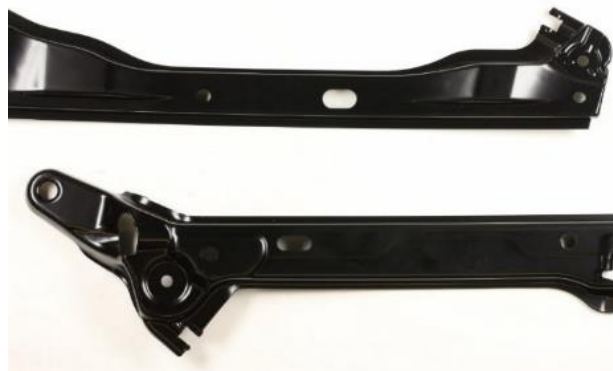
Figure 1. Powder coated guide rails

As mentioned in the motivation, this thesis will focus on parts of the two main Brose business divisions, the door and seat systems. The door system consists of products, which are built into car doors and provide them with various functionalities, the main one being the power windows. The power window assembly further breaks down into components like the electromotor, guide rail, cables and polymer parts. The guide rails, shown in figure 1, are made from aluminium

or hot dip galvanized steel and subsequently powder coated to receive their full range of protective and functional properties.

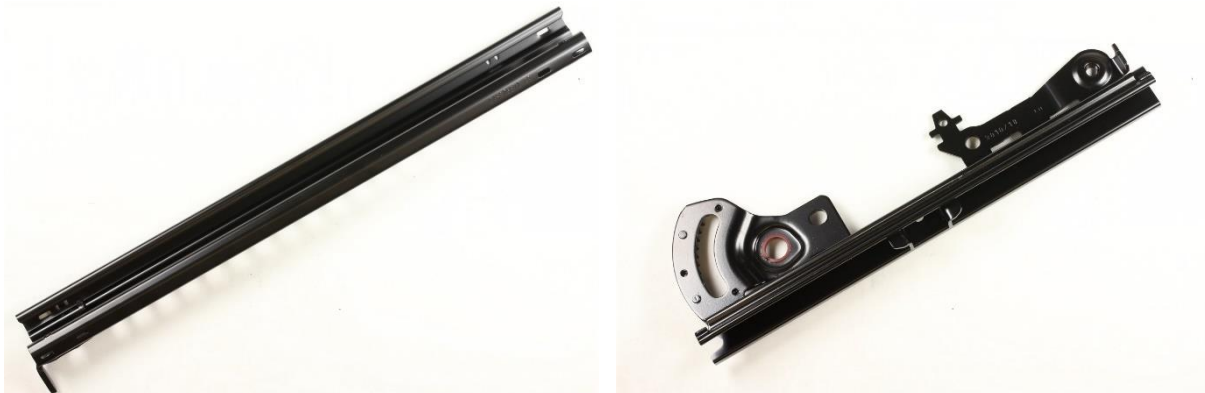
Figure 2. Cathodic electrodeposition coated seat adjusters

Steel on its own, even being utilized in the relatively inert cars interior, does not showcase sufficient corrosion resistance nor aesthetic properties. Therefore, the seat adjusters are coated by the process of cathodic electrodeposition.

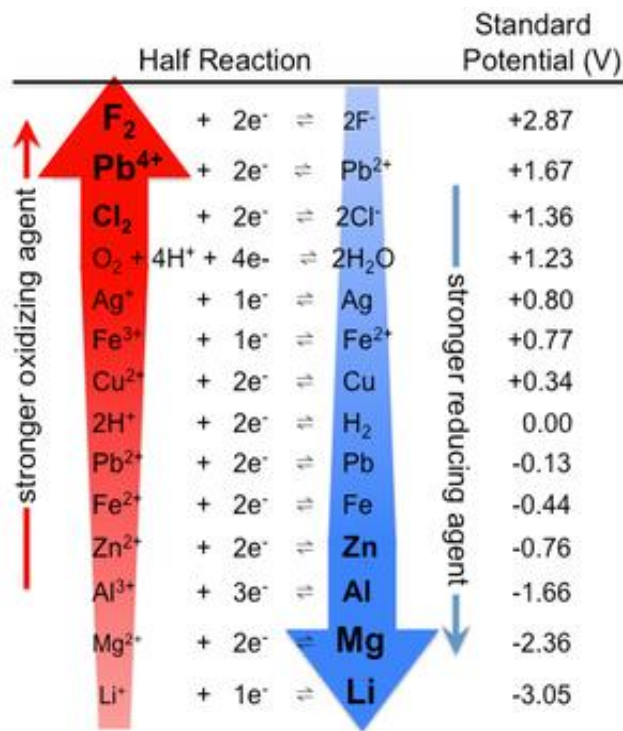
Figure 3. Metals in relation to their standard electrochemical potential [4]

Metallic coatings are a popular stand-alone method of protection for structures made of metals, which are utilized in a relatively non-corrosive environment. They can also be used as a base coat within a multi layered coating system to substantially increase its protective properties. When designing any corrosion protection system with metallic coatings, the considered metals are classified by their standard electrochemical potentials, which describe the metals readiness to either receive or give electrons. The electrochemical potentials of metals in relation to a standard hydrogen electrode are well documented and are usually shown in form of electrochemical voltage series as in figure 3 [4].

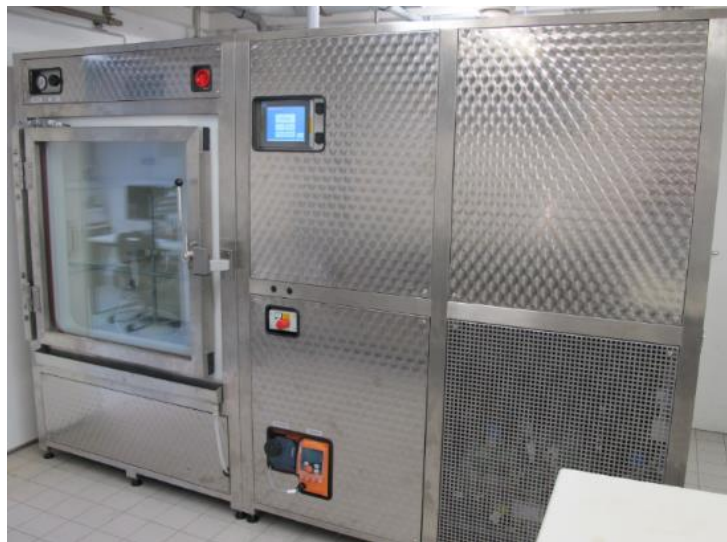
Figure 8. “HKS 700” climatic test chamber

It is obvious that Brose must test their parts according to those new tests and document the outcome in order to sell products that are satisfactory to the customers. Consequently, the company invested in a new climatic-test chamber, “HKS 700”, which can carry out virtually any standardized accelerated corrosion test (Figure 8).

The practicality to have one machine, which can run a plethora of different tests on demand, is undeniable. Moreover, Brose can now test their parts according to the contemporary VDA 233-102 test, as well as the Volvo and Ford tests with shower phases.

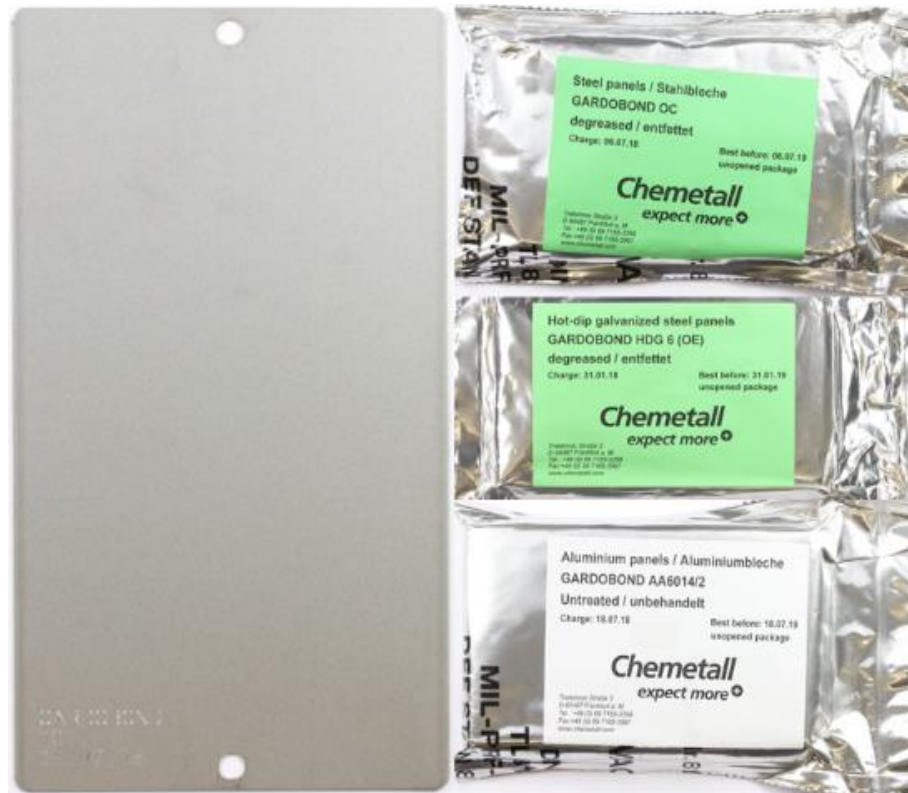
Figure 9. The chosen substrates from the company “Chemetall”

As already mentioned in the previous part, coated specimens will be used for the testing instead of actual car parts. In order to stay true to the original parts, the chosen substrates are virtually identical to those of the parts. The selected coatings will be applied to three different substrates; steel, hot dip galvanized steel and aluminium, all from the company “Chemetall”. Displayed in figure 9, “Gardobond OC” stands for the steel substrates, “Gardobond HDG 6” for the hot-dip galvanized steel substrates and “Gardobond AA6014/2” for the aluminium substrates shown in figure 9. The chosen substrates have a rectangular shape, 190 mm long, 105 mm wide and 0,8 mm thick, the only exception being the aluminium substrate with 1.2 mm of thickness. All substrates also have two holes, one in the bottom and one in the top, in order to be adequate for various coating methods.

Just like the car parts, the substrates are manufactured by shearing the shape out of a continuous metal coil with the help of a punch and a die. The process of shearing is already established in the automotive industry and its many variations are well described. Generally, it is carried out in a press where a sheet of metal is placed on a die. While the blank holder immobilizes the sheet, the punch cuts the metal with a high shearing force around the die. Shearing is characterized by low costs, high productivity and the ability to be automatized. Figure 10 shows the shearing process with its distinctive edge formation [13].

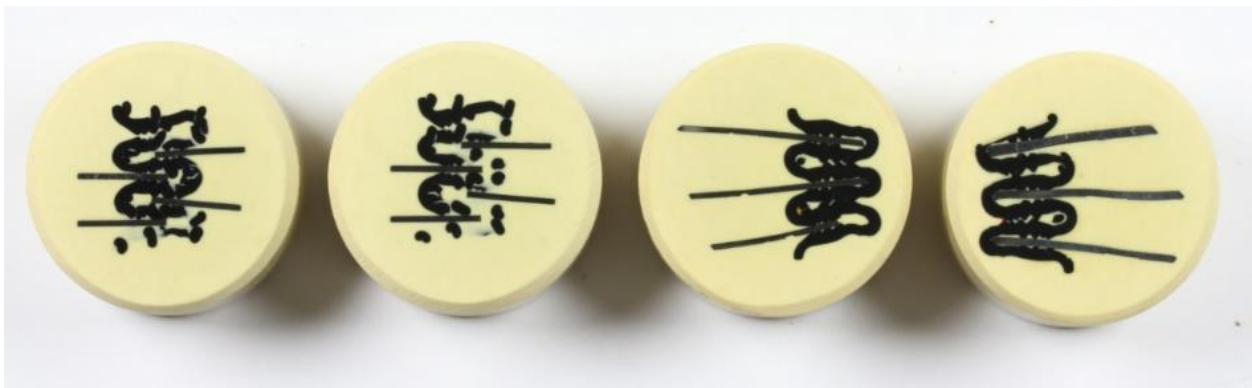
Figure 11. Embedded specimen samples for optical microscopy

The samples will then be mounted using a “Struers CitoPress” mounting press. White “IsoFast” granulate from “Struers” will be used as the mounting polymer. The white colour of the polymer will provide a great contrast to the black coatings, which have to be clearly visible.

The embedded samples (Figure 11) will be ground in a “Struers Tegramin” automated grinding and polishing machine. The last grinding step will be at 4000 grit, after which a manual water free polishing step at 1 micrometre will follow.

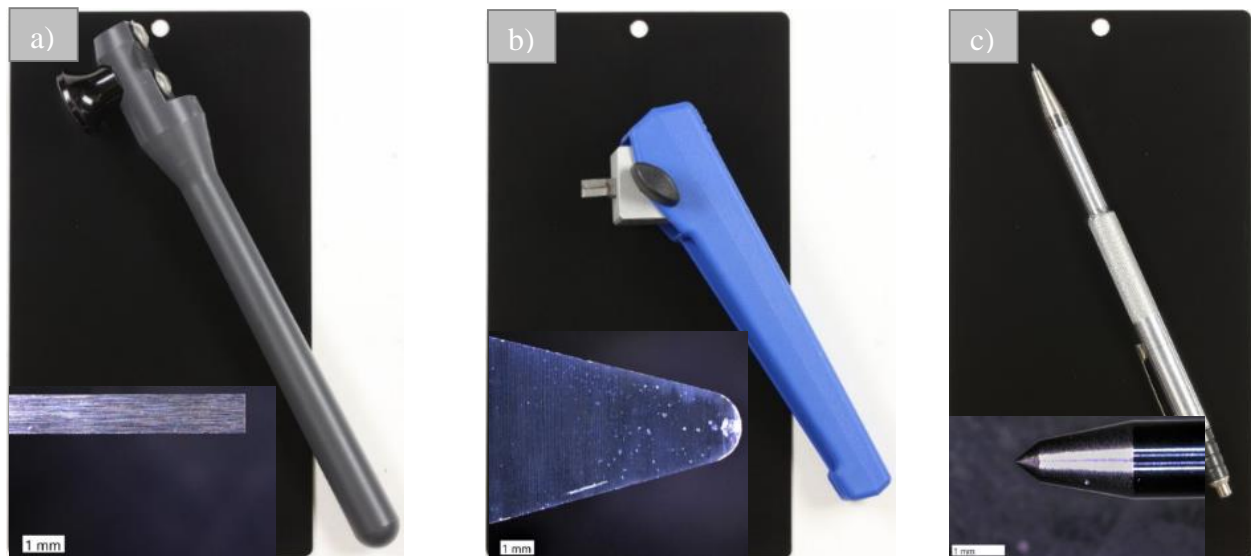
Figure 17. Scribing tools with respective scribing tips a) Sikkens b) Clemen c) Van Laar

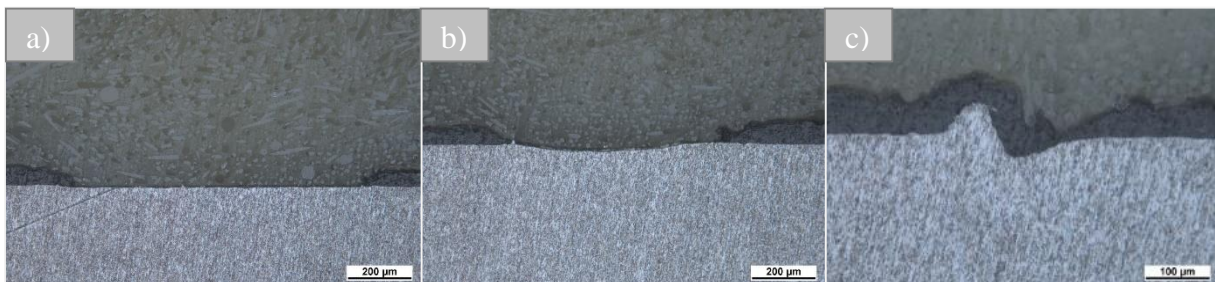
Figure 19. Cross section samples of the scribe lines a) Sikkens b) Clemen c) van Laar

In the next step, representative crosscut samples are made from scribed specimens in order to define the scribe marks from a different perspective (Figure 19).

The tip according to Sikkens leaves a one millimetre wide scribe line with the substrate fully exposed across the whole surface. The tip according to Clemen, leaves a slightly narrower U shaped groove, while the van Laar pen makes a slightly angled V shaped groove. The angle of the groove is most likely connected to the nature of handling the tool like a pen, when scribing. Peculiarly, the groove made by the van Laar pen is seemingly filled with the coating of the specimens. This appearance, together with the other scribe lines will be additionally examined in the SEM (Figure 20).

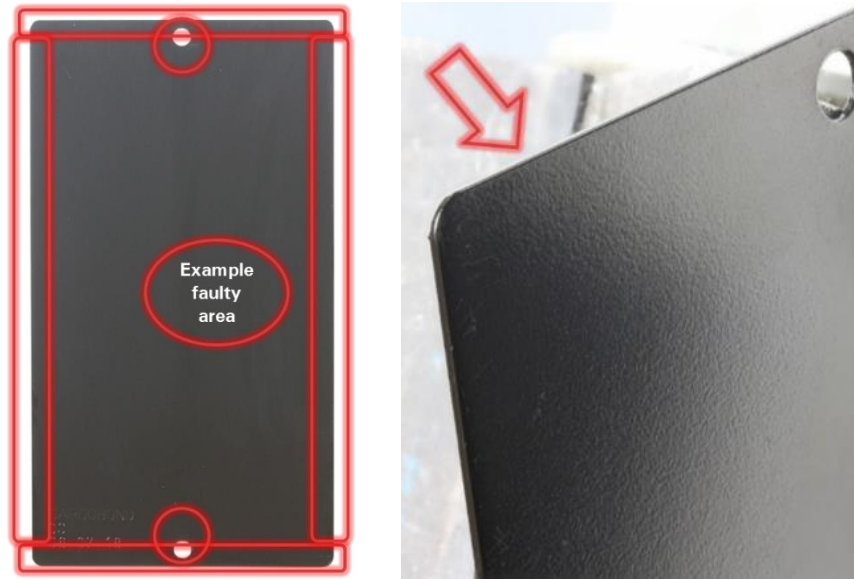
Figure 22. Example specimens with marked areas, which are excluded from the degree of rusting evaluation

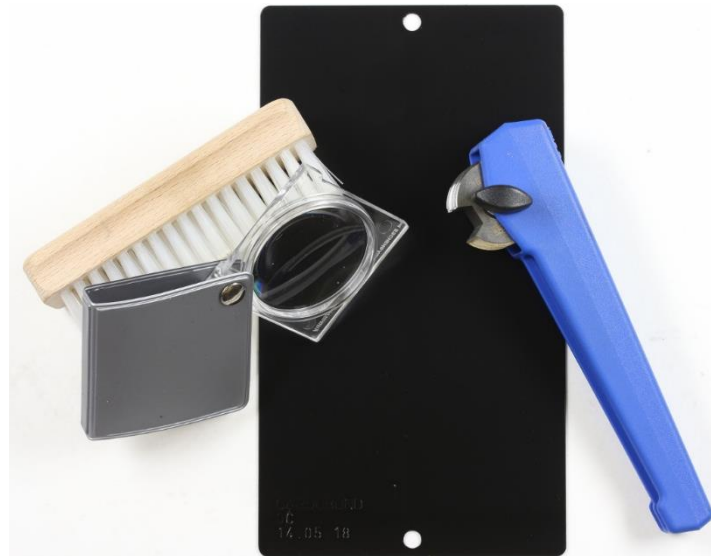
Figure 25. Cross cut tool with brush and magnifying glass from „Erichsen“

The test is carried out by a specialized tool from the company “Erichsen” (Figure 25), which makes six parallel lines in one pull. The magnifying glass is used for the evaluation, while the brush can be used to remove excess coating remains after cutting. Six parallel lines are cut into the specimen, piercing the coating all the way to the substrate. Another six lines, at a 90° angle, cross those lines, resulting in 25 square shaped tiles (Figure 26) [21].

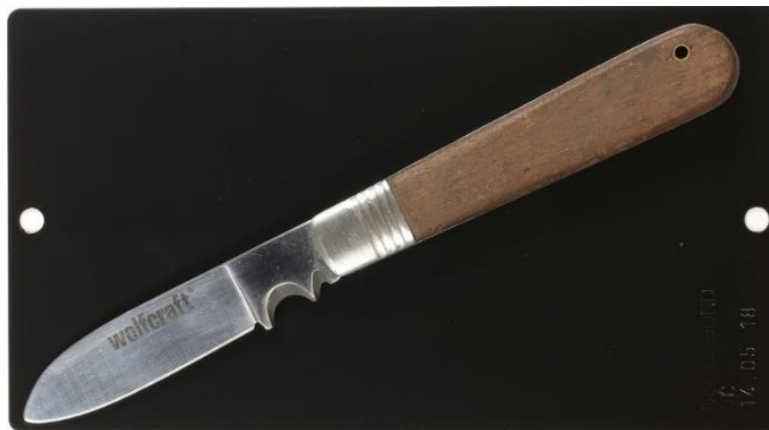
Figure 28. “Wolfcraft” knife used to scratch the specimen surface

This is a specific test enforced by the customer Daimler. The test is another method for determining the adhesion between a coating and a substrate. The test can be carried out both prior and after accelerated corrosion tests. The initial test grade can then be compared to the grade after testing to determine if any decrease in adhesion occurred. The test is carried out by a special knife prescribed by Daimler (Figure 28).

The coating is scratched by holding the blade vertical to the substrate surface and pulling it while simultaneously pressing down. The resulting scratch is then graded from K0 to K5 according to the descriptions in the DBL standard [23]. Figure 29 depicts the first four grades of the scratch test.

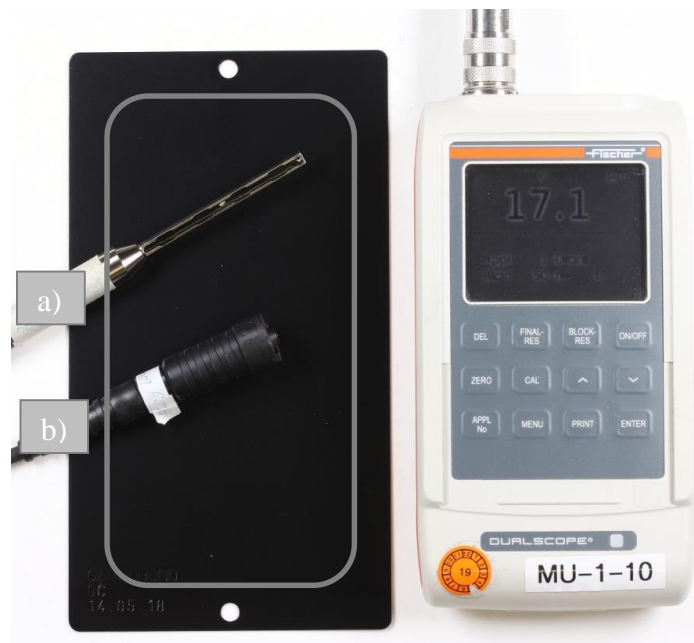
Figure 30. „Dualscope MP 40“coating thickness measuring device with a) ferrous substrate probe b) aluminium substrate probe

In this specific case, the acceptable range for CED coatings, defined in the BN 562161-107, is 15  $\mu\text{m}$  to 30  $\mu\text{m}$ . For powder coatings, the range is set much higher, from 40  $\mu\text{m}$  to 120  $\mu\text{m}$ , as defined in BN 587000-112. Coating thickness of the specimens will be measured with “Dualscope MP 40” measuring device (Figure 30), based on the magnetic induction principle.

Coating thickness is measured at five points on two random specimens for every coating variant, within the grey area indicated in figure 30. Measurements on two separate specimens are made in order to better approximate the average coating thickness across all specimens. Conflictingly, this slightly increased the scattering of the coating thickness, indicated with error bars in the following charts. Figure 31 shows the average coating thickness of CED coated specimens, where the green area indicates the acceptable coating thickness range prescribed in the Brose standard.

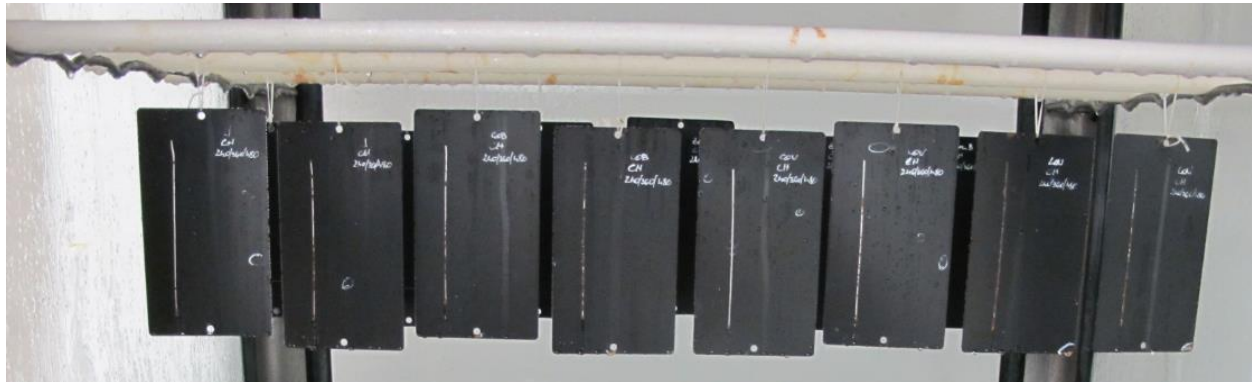
Figure 35. Placement of the specimens in the CH test chamber

The test is carried out in the “HK 400 M” climatic chamber. During the test, the bottom of the chamber is filled with at least 10 mm of deionized water. Specialized heaters raise and maintain the temperature at 40 °C. Water evaporates from the resulting heat but cannot exit the chamber, which makes the inside environment extremely humid. Condensation drops form on the surface of the specimens, as their temperature is lower than the surrounding temperature.

According to the standard the specimens are placed at least 100 mm from the chamber walls, 200 mm from the water surface and 20 mm from each other. It is also important to ensure that no condensate is dripping on the specimens during the test. The standard also prescribes, that the examined surface should be angled at  $60^\circ$  or greater to the horizontal plane [24]. Therefore, as the most practical solution, the specimens are hung from polymer rods by waxed strings, shown in figure 35.

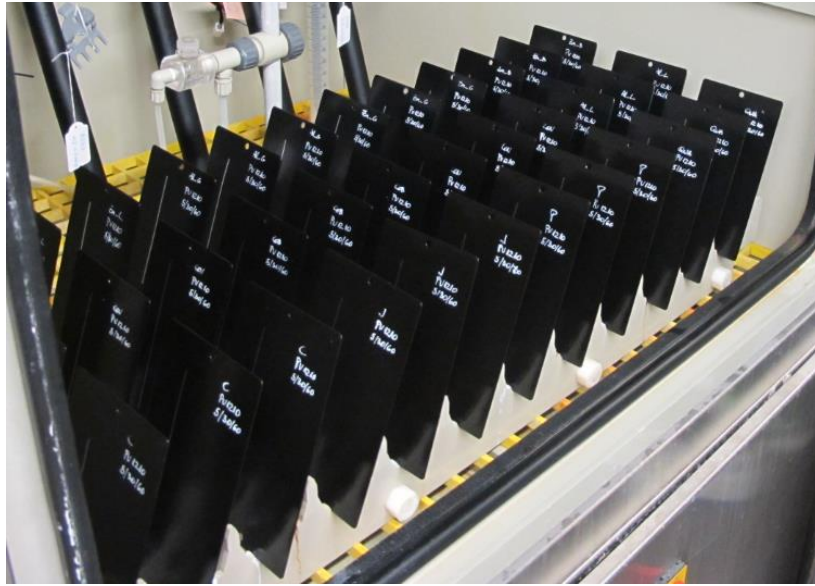
Figure 41. Placement of the specimens in the PV 12010 test chamber

The test is carried out in the “HKS 1000” climatic chamber. The sample carriers are identical to the ones used in the NSS and Cycle-B test (Figure 41).

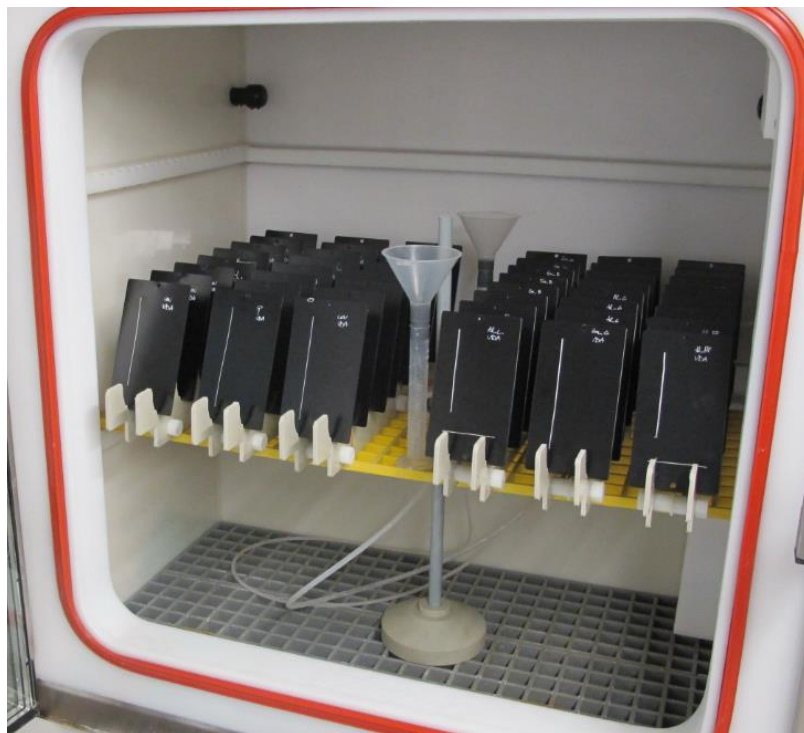
Figure 47. Placement of the specimens in the VDA-new test chamber

Specimens with scribe lines are placed in identical simple carriers as in the NSS test, with one side facing up at a 20° angle to the vertical plane (Figure 47).

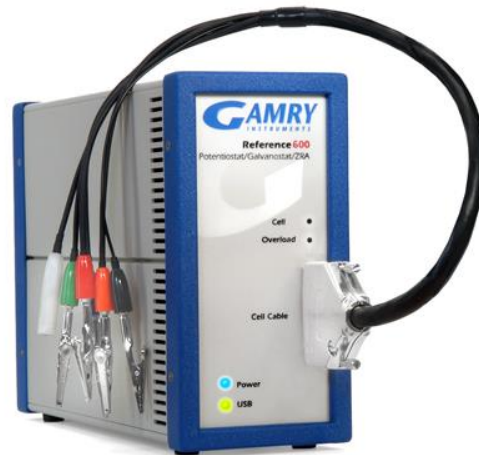
Figure 56. „Gamry Reference 600“ potentiostat [40]

EIS is most commonly run in three electrode mode. The working electrode is represented by the coated specimen, the counter electrode is usually graphite or platinum. There are many choices for an independent reference electrode, saturated calomel electrodes (SCE) and silver/silver chloride being most common ones. The electrodes are then mounted into a cell which contains an electrolyte of choice. Electrolytes are generally chosen to reflect the service condition, the most common ones being sodium chloride solutions. The electrode area of the sample exposed in the cell should be relatively large. Statistically, a larger area has a higher probability of highlighting a defect in the coating while also working with higher currents, which speeds up the measuring process. A larger area also guarantees that no singular coating imperfection has a major influence on the results [33]. A Faraday cage is often used to negate outside electrical disturbances and ensure a smooth measurement.

The EIS tests for this thesis will be carried out in the “Gamry Paracell” (Figure 57) cell connected to the “Gamry Reference 600” potentiostat (Figure 56).

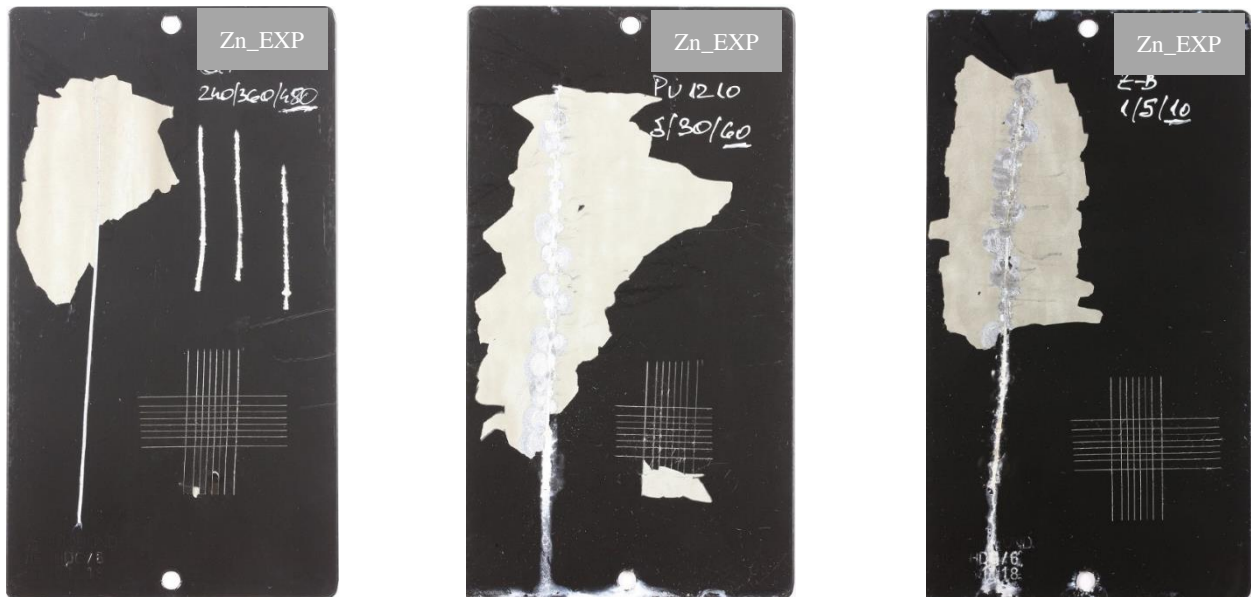
Figure 59. Zn\_EXP specimens with poor coating adhesion after 480 hours of CH, 60 cycles of PV 1210, and 10 cycles of Cycle –B test

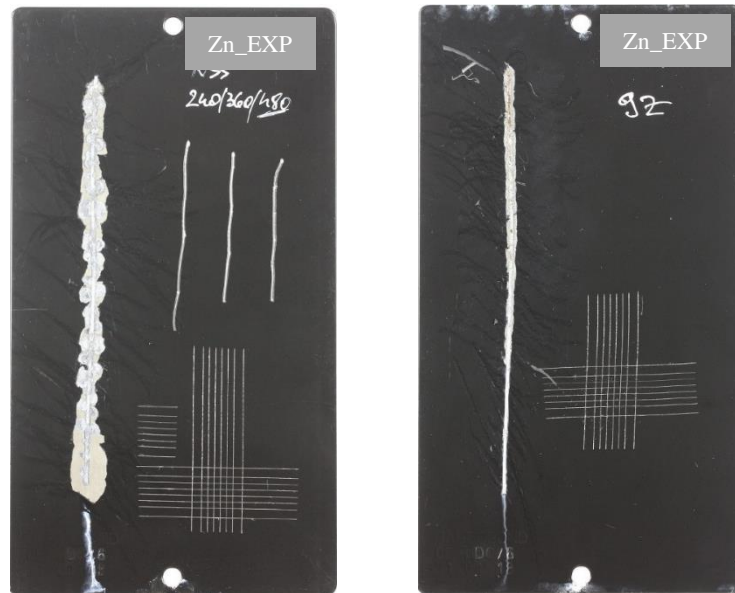
Figure 60. Zn\_EXP specimens with adequate coating adhesion after 480 hours of NSS and 9 cycles of VDA-new test

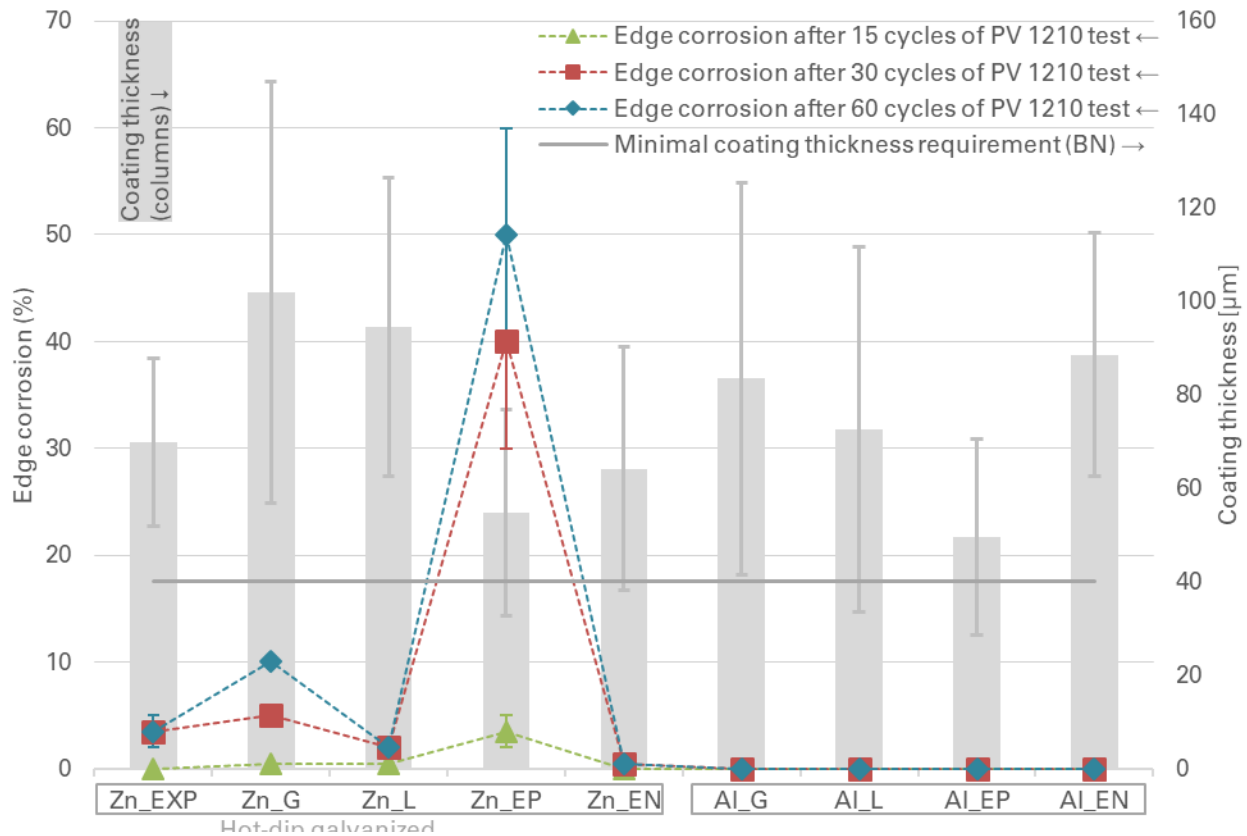
Figure 79. Comparison of edge corrosion results (colored symbols) on powder coated specimens, after 15, 30 and 60 cycles of the PV 1210 test, in relation to coating thickness (columns) and different substrates

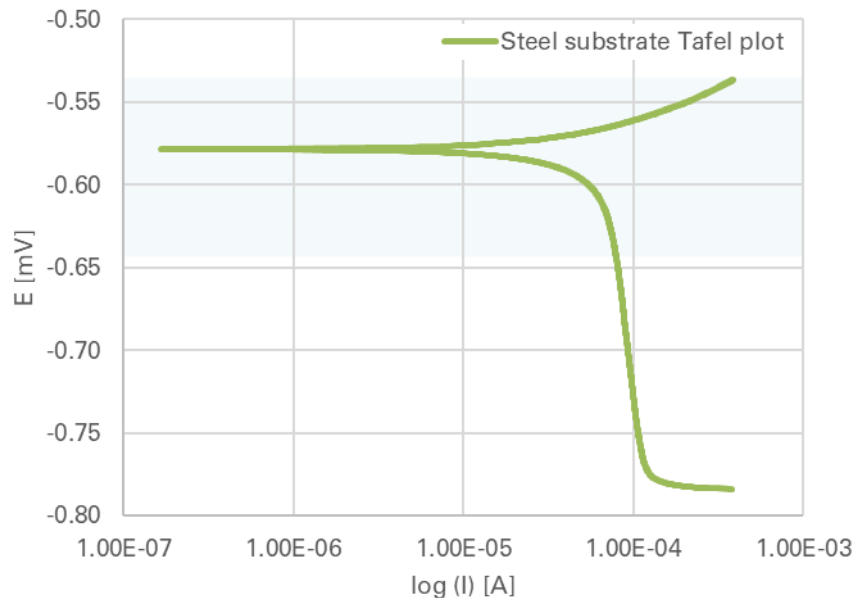
Figure 100. Steel substrate Tafel plot, measured with „Gamry Paracell“ in 5% sodium chloride solution
