# Ocjena zaštitnih svojstava organiskih prevlaka na različitim metalnim podlogama

**Master's thesis / Diplomski rad**

Naslov rada na engleskom jeziku: **Evaluation of corrosion protection properties of organic coatings on different metal substrates**

Key words: corrosion, organic coatings, accelerated corrosion tests, VDA 233-102 standard, electrochemical impedance spectroscopy

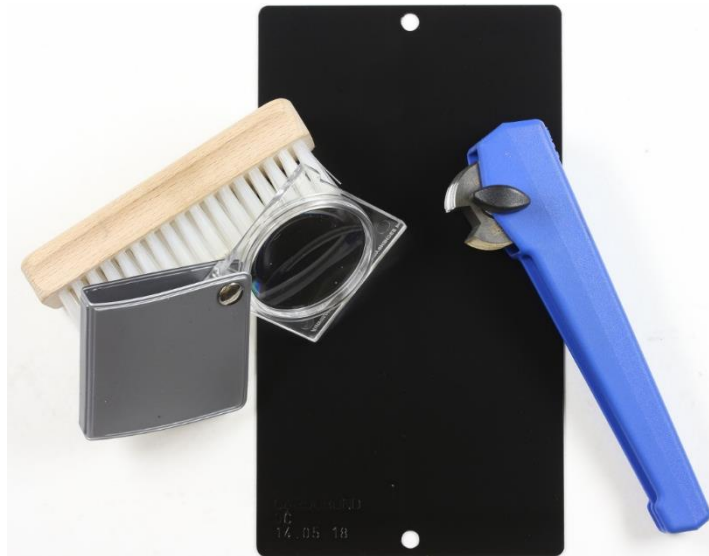
Figure 25. Cross cut tool with brush and magnifying glass from „Erichsen“

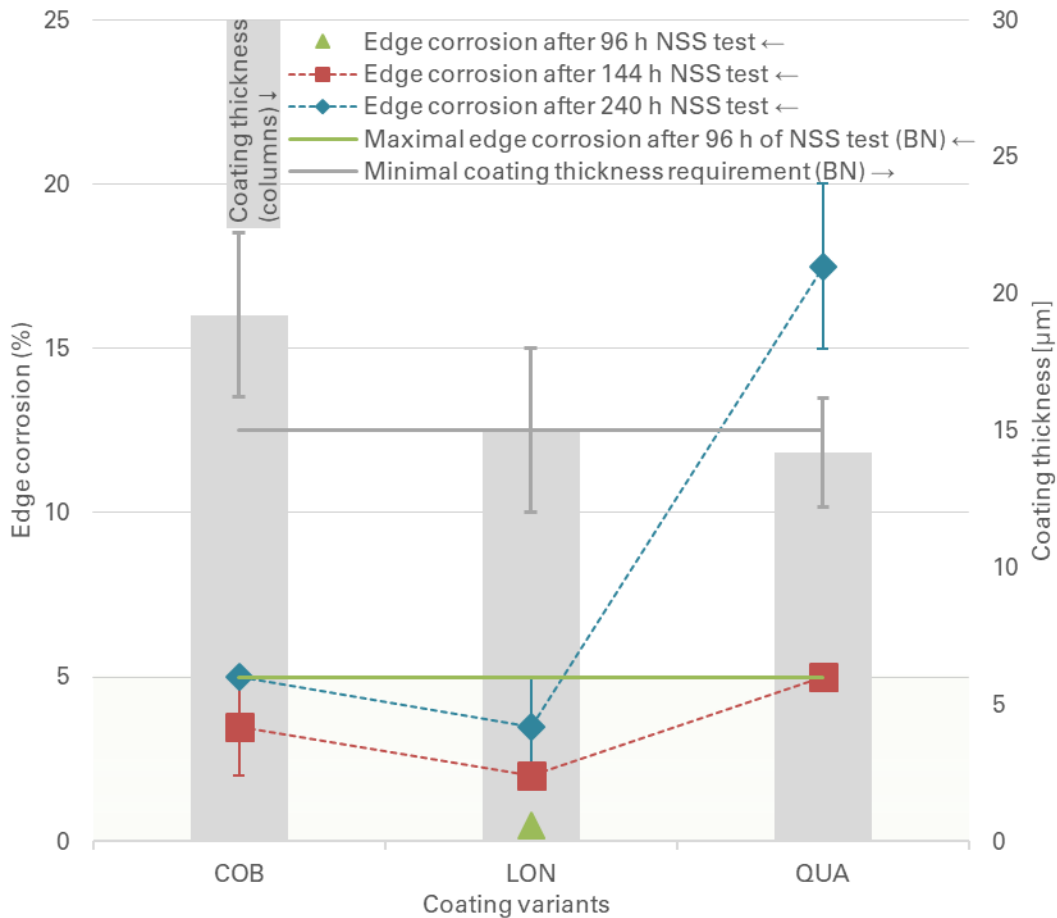
Figure 89. Comparison of edge corrosion results (colored symbols) on CED coated specimens, after 96, 144 and 240 hours of the NSS test in relation to coating thickness (Laboratory for the protection of materials)
