Ocjena zaštitnih svojstava organiskih prevlaka na različitim metalnim podlogama

Master's thesis / Diplomski rad

UNIVERSITY OF ZAGREB
FACULTY OF MECHANICAL ENGINEERING AND
NAVAL ARCHITECTURE

Naslov rada na engleskom jeziku: **Evaluation of corrosion protection properties of organic coatings on different metal substrates**

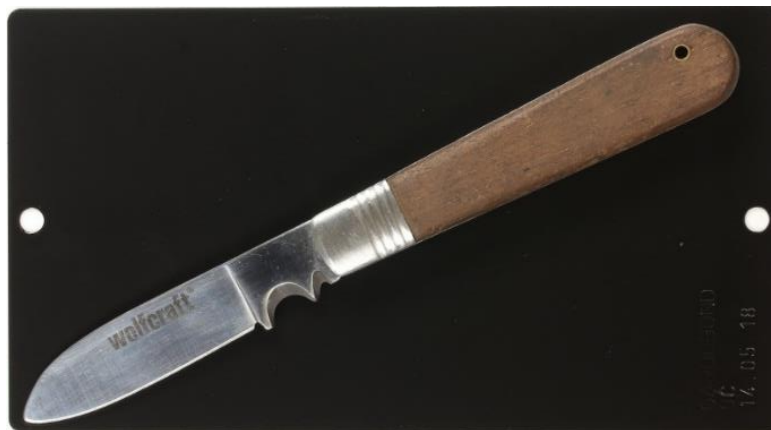
Figure 28. “Wolfcraft” knife used to scratch the specimen surface

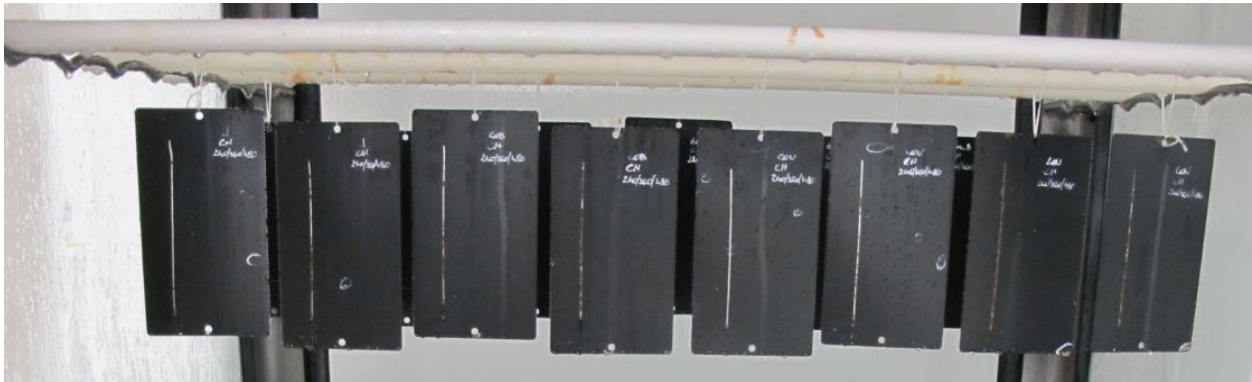
Figure 35. Placement of the specimens in the CH test chamber

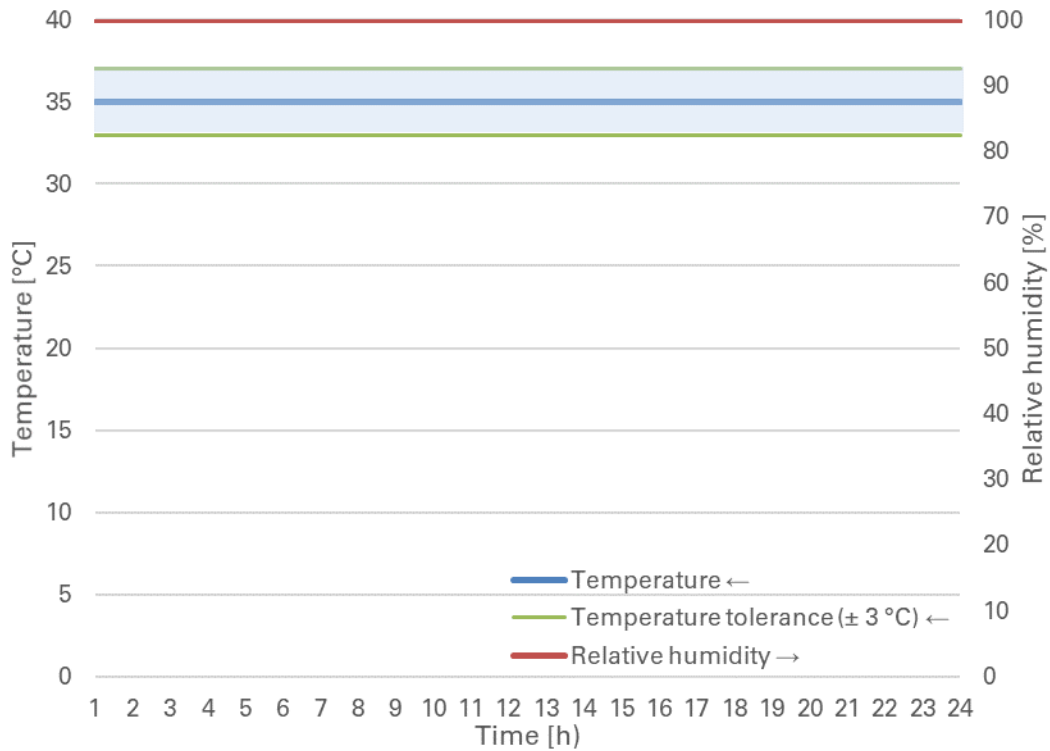
Figure 36. NSS test operating parameters

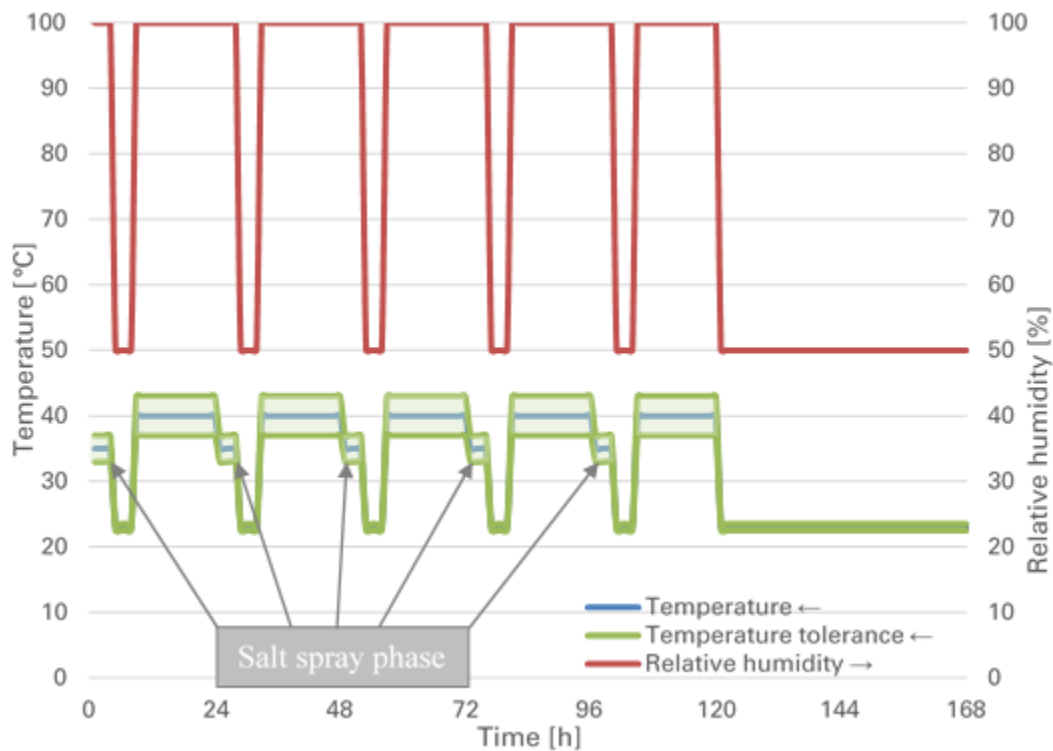
Figure 40. PV 1210 test operating parameters (humidity tolerance too narrow to be indicated -1,5 %)

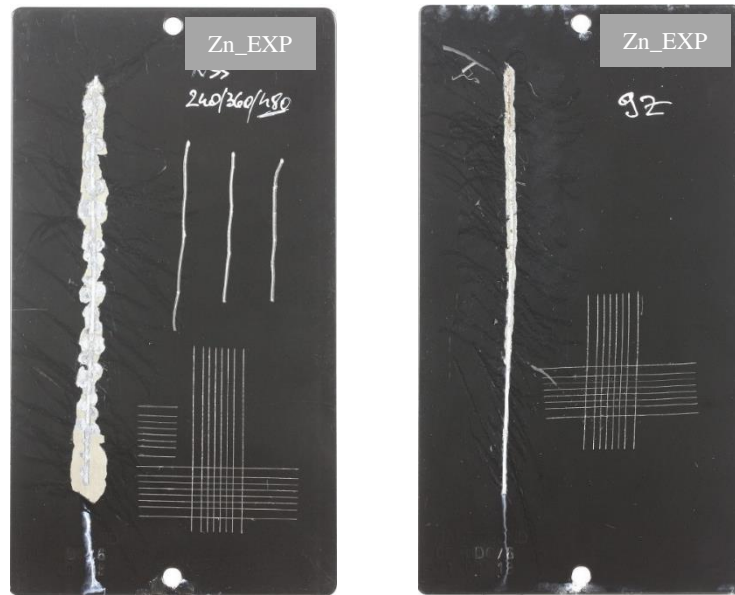
Figure 60. Zn_EXP specimens with adequate coating adhesion after 480 hours of NSS and 9 cycles of VDA-new test

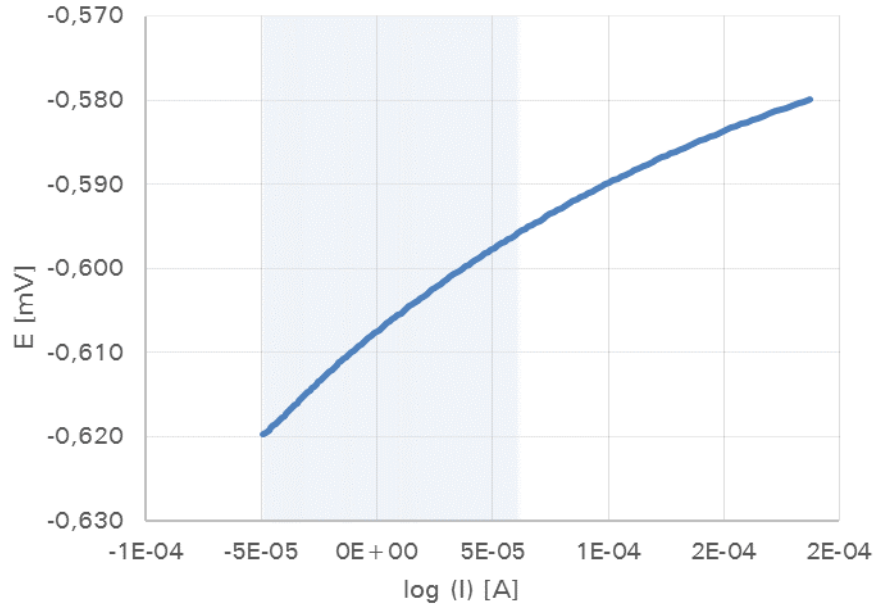
Figure 101. Steel substrate polarization resistance plot, measured with „Gamry Paracell“ in 5% sodium chloride solution

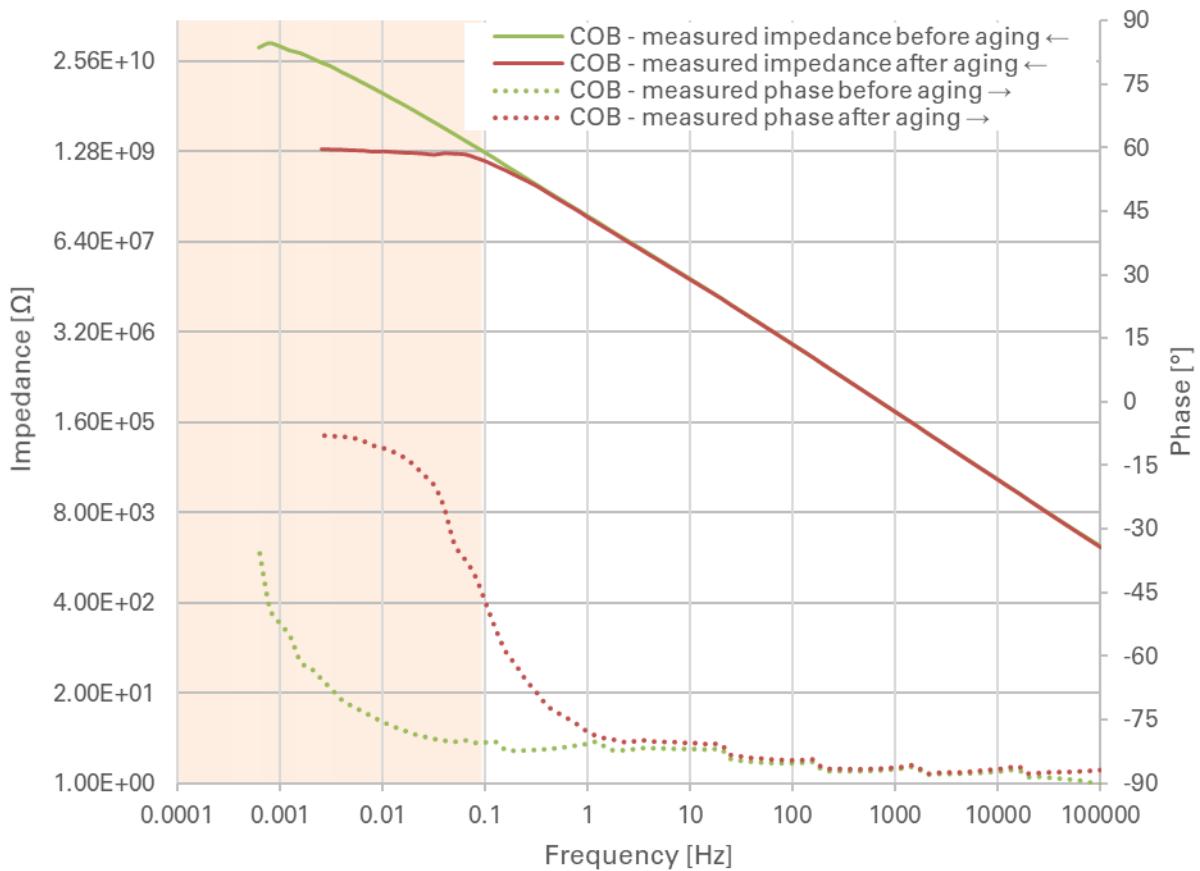
Figure 102. Bode plot with matching phase plot for specimen COB, measured in saturated sodium chloride solution, before (green lines) and after (red lines) 24 days of aging in 5% sodium chloride solution
