Ocjena zaštitnih svojstava organiskih prevlaka na različitim metalnim podlogama

Master's thesis / Diplomski rad

Naslov rada na engleskom jeziku: **Evaluation of corrosion protection properties of organic coatings on different metal substrates**

The aim of this masters thesis “Evaluation of corrosion protection properties of organic coatings on different metal substrates” is to examine the corrosion resistance properties of various CED and powder coatings, commonly utilized in the automotive industry. For this purpose, standardized steel, hot-dip galvanized steel and aluminium specimens are coated and subsequently tested in accelerated corrosion tests, the emphasis being on the climatic test according to VDA 233-102. The protective properties of the coatings are additionally studied using DC and AC electrochemical methods.

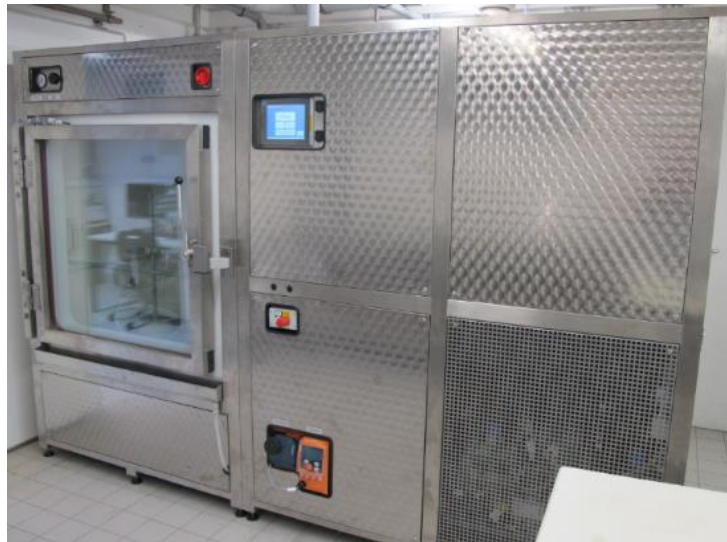
Figure 8. “HKS 700” climatic test chamber

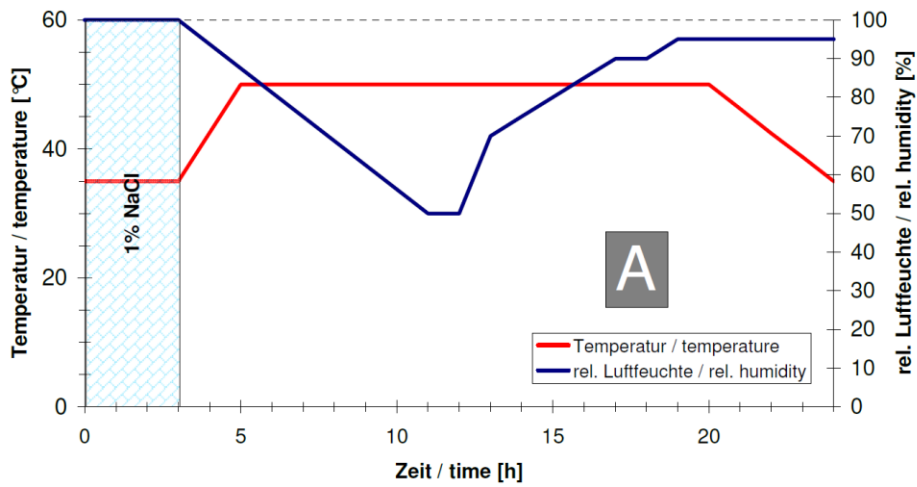
Figure 44. Graphical representation of phase A in the VDA-new test [29]

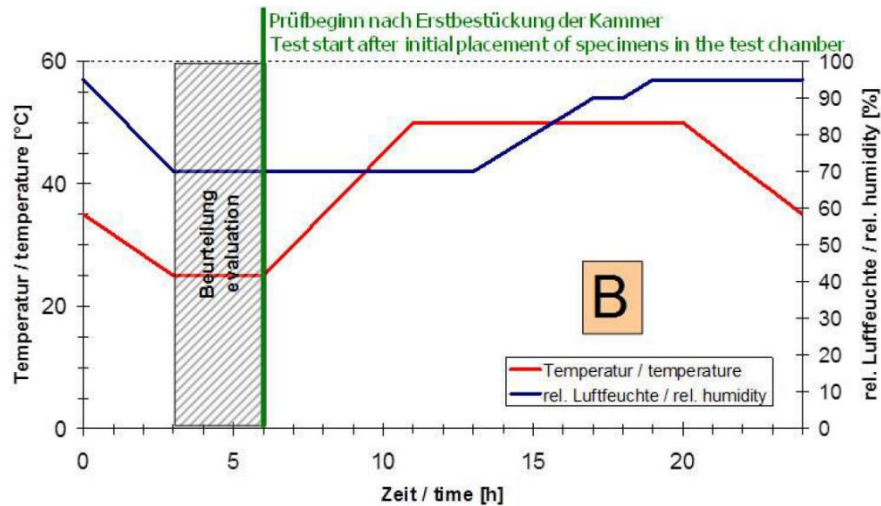
Figure 45. Graphical representation of phase B in the VDA-new test [29]

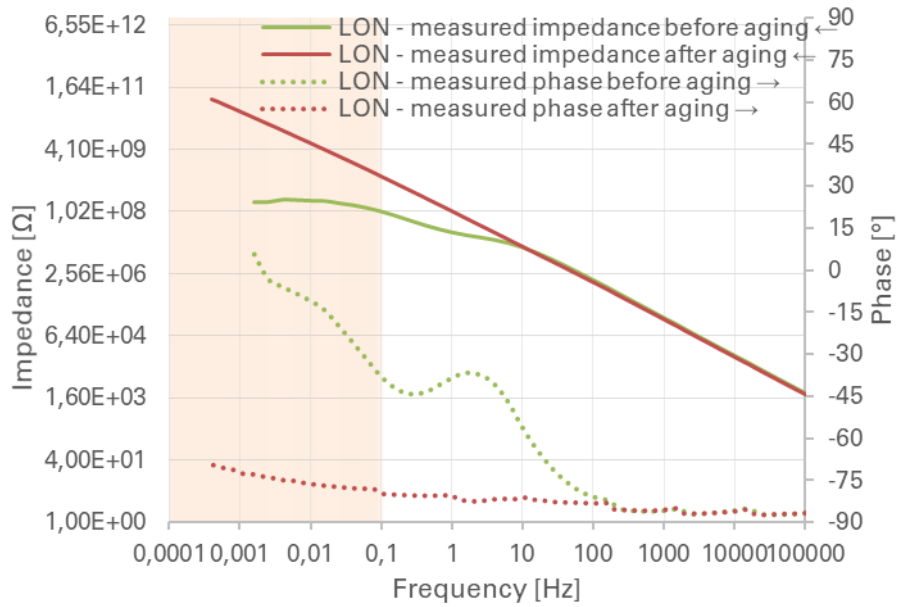
Appendix 18. Bode plot with matching phase plot for specimen LON, measured in saturated sodium chloride solution, before (green lines) and after (red lines) 24 days of aging in 5% sodium chloride solution
